# Toronto Islands Flood Characterization and Risk Assessment Project

## Flood Mitigation Alternatives Report

4 June 2019 | 13017.101.R3.Rev1\_FloodMitigation

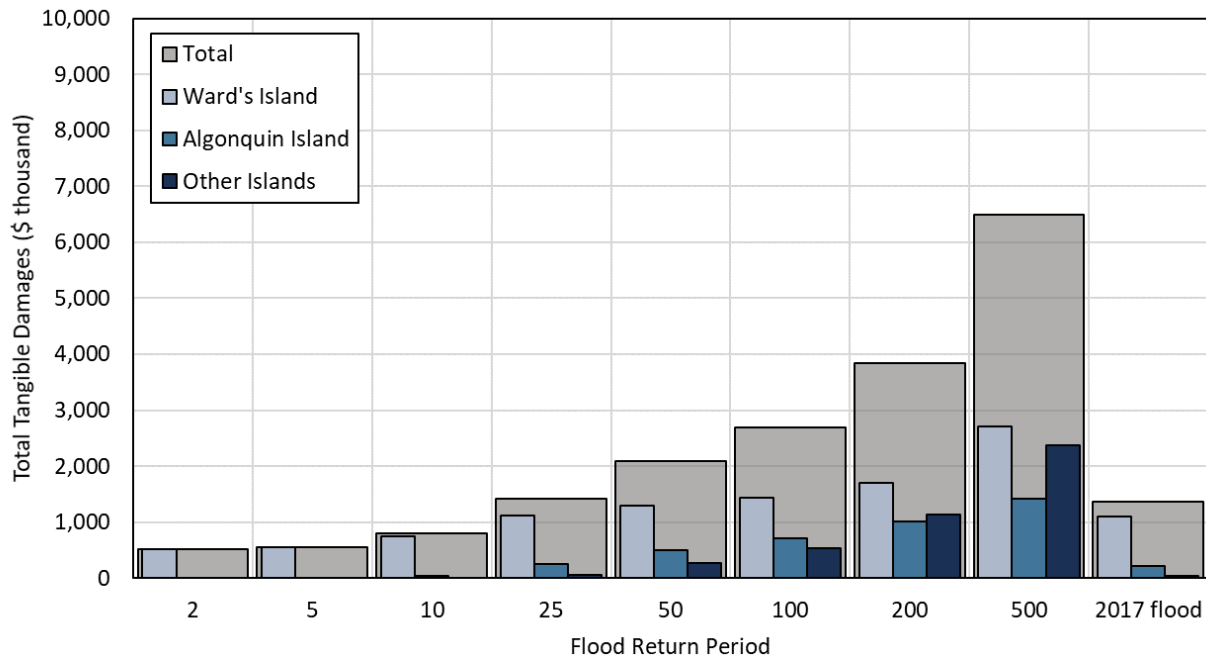
**Figure 1.1: Total Tangible Damages for Different Flood Return Periods (from Baird, 2019b)**

Financial and non-financial damages for different return period flood levels were estimated in Baird (2019b). The estimated total financial damages to residential and non-residential buildings on Toronto Islands (excluding City of Toronto owned and operated buildings) varies from \$0.5M at the 2-year flood to \$6.5M for the 500-year flood (see Figure 1.1). The damage estimates consider only buildings that were flooded and do not account for mitigation actions (such as sandbags and pumps). Financial damages for non-residential

buildings (business disruption, lost productivity, etc.) are believed to be underestimated due to limitations inherent to the method. Financial damages incurred by the City of Toronto in 2017 were mostly due to the closure of Toronto Island Park (lost ferry revenues, rent abatements, etc.) and flood mitigation actions (labour, equipment, etc.) rather than damages to flooded City buildings. The estimated financial impact of the 2017 flood on the City was approximately \$8M (City of Toronto, 2018). The average annual financial damages<sup>1</sup> for the residential and non-residential buildings on Toronto Islands is estimated to be \$387,000 per year. Non-financial damages such as impact of flooding on human health, environment, and the Toronto Islands community is discussed in Baird (2019b).

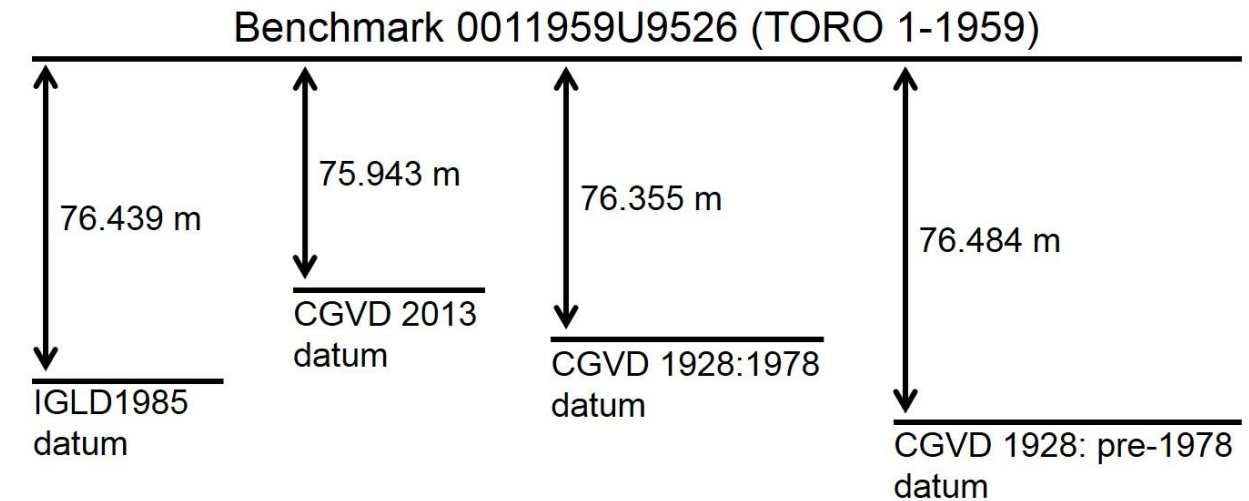
Figure 1.2: Elevation of the Toronto Harbour Gaugehouse Benchmark

Unless otherwise noted, all water levels are reported in International Great Lakes Datum 1985 (IGLD85). IGLD85 is 8.4 cm below Canadian Geodetic Vertical Datum 1928-1978 Ontario Adjusted Version (CGVD 1928:1978), and 49.6 cm below Canadian Geodetic Vertical Datum 2013 (CGVD 2013) at the Canadian Hydrographic Service benchmark 0011959U9526 (also known as 00159U9526, 59U9526, and TORO 1-1959). The benchmark is located at the Toronto Harbour Gaugehouse at the south side of Queen's Quay. The elevation of the benchmark relative to the different datums is shown in Figure 1.2

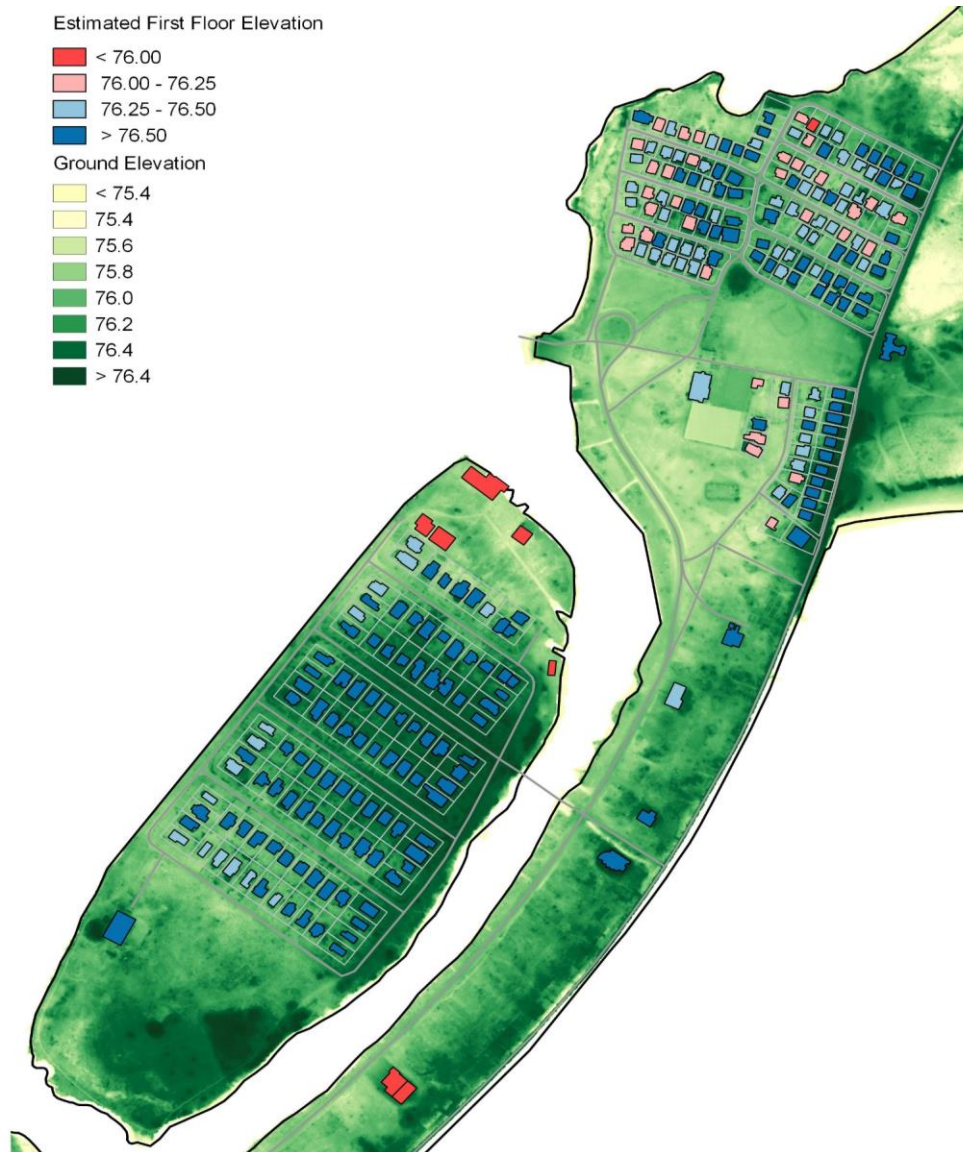
**Figure 3.1: Estimated First Floor Elevation and Ground Elevation on Algonquin and Ward's Islands**

The Toronto Islands are low-lying with ground elevations generally less than 1 m above the annual high water level. Ground elevations and estimated first floor elevations<sup>2</sup> of buildings on Algonquin and Ward's Islands are shown in Figure 3.1. First floor elevations below the 50-year and 500-year stillwater level are coloured in red and pink, respectively.

<sup>2</sup> First floor elevations were estimated from the number of steps at the front entrance and the ground elevation from the Digital Elevation Model for Toronto Islands.

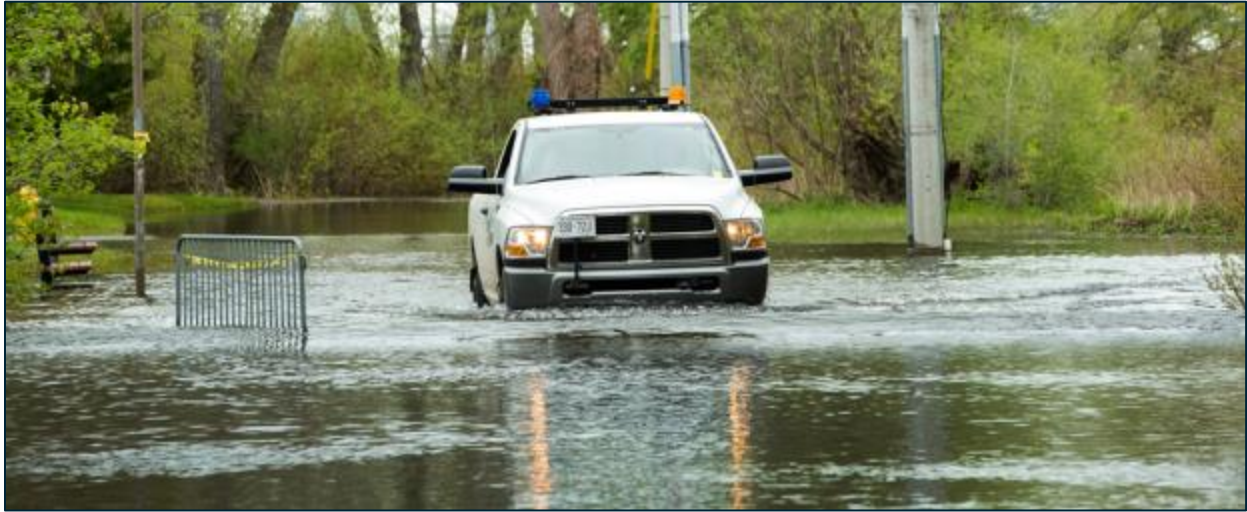
**Figure 3.2: Photograph of Cibola Ave. During 2017 Flood (from National Post, 2017)**

The flood depth maps produced for a lake level of 76.2 m (approximately the 500-year flood event) are included in Appendix A to provide context for the flood mitigation alternatives presented in the report. The maps use one colour scale to show the depth of flooding on land, and another scale to show the depth of flooding on the arterial roads. An example of the flooding that occurred along parts of Cibola Ave. in 2017 is shown in Figure 3.2. The 500-year flood level is approximately 0.3 m higher than the water level in the photograph.

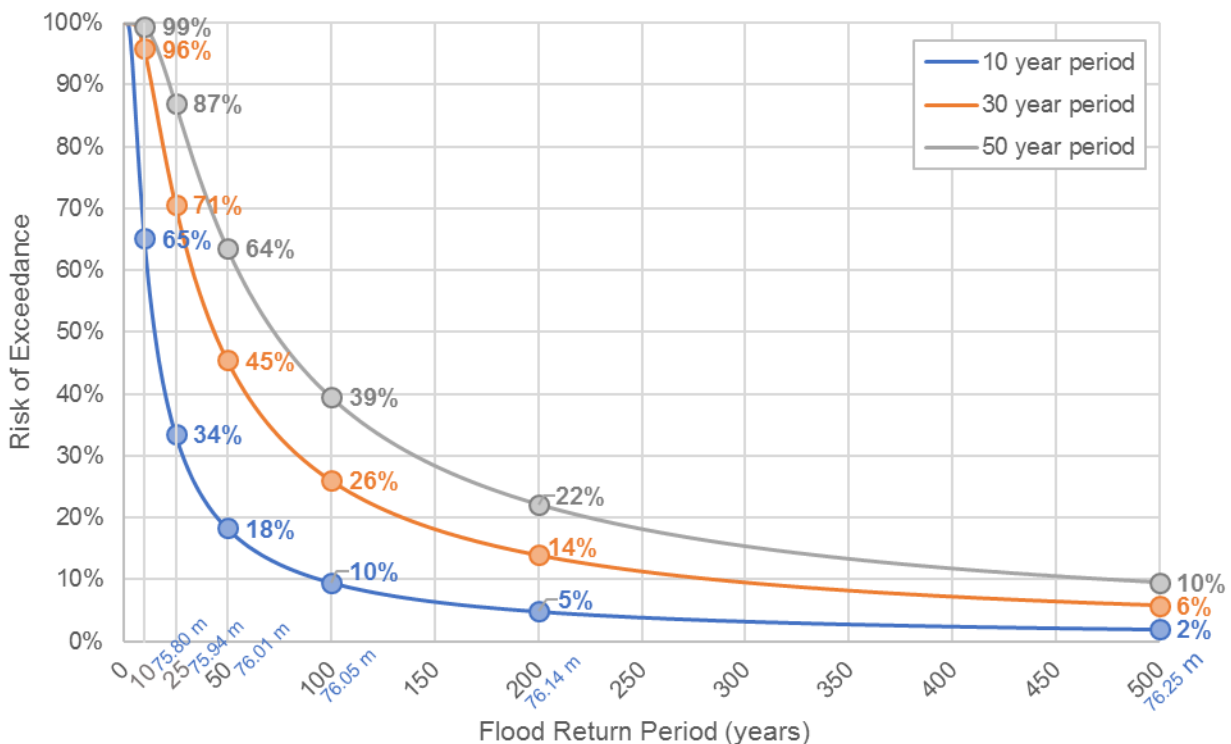
**Figure 4.1: Probability of a Specified Flood Event Occurring within a 10, 30, and 50 Year Period (after FEMA, 2014)**

The conceptual designs were developed using the 500-year stillwater level for Toronto (static lake level plus storm surge) as the design condition. The 500-year flood event has a 0.2% chance of being equalled or exceeded in a given year, which results in a 6% chance of being equalled or exceeded at least once in a 30 year period (see Figure 4.1). In comparison, there is a 26% chance the 100-year flood level will be equalled or exceeded at least once over a 30 year period. Considering that the risk of the 100-year flood level being equalled or exceeded at least once over a 50 year period is nearly 40%, the 500-year flood level was selected as a reasonable starting point to develop the conceptual alternatives. The level of acceptable risk, construction costs, and other factors should be evaluated at the next stage of the design. The difference between the 100-year and 500-year flood level is 0.2 m.

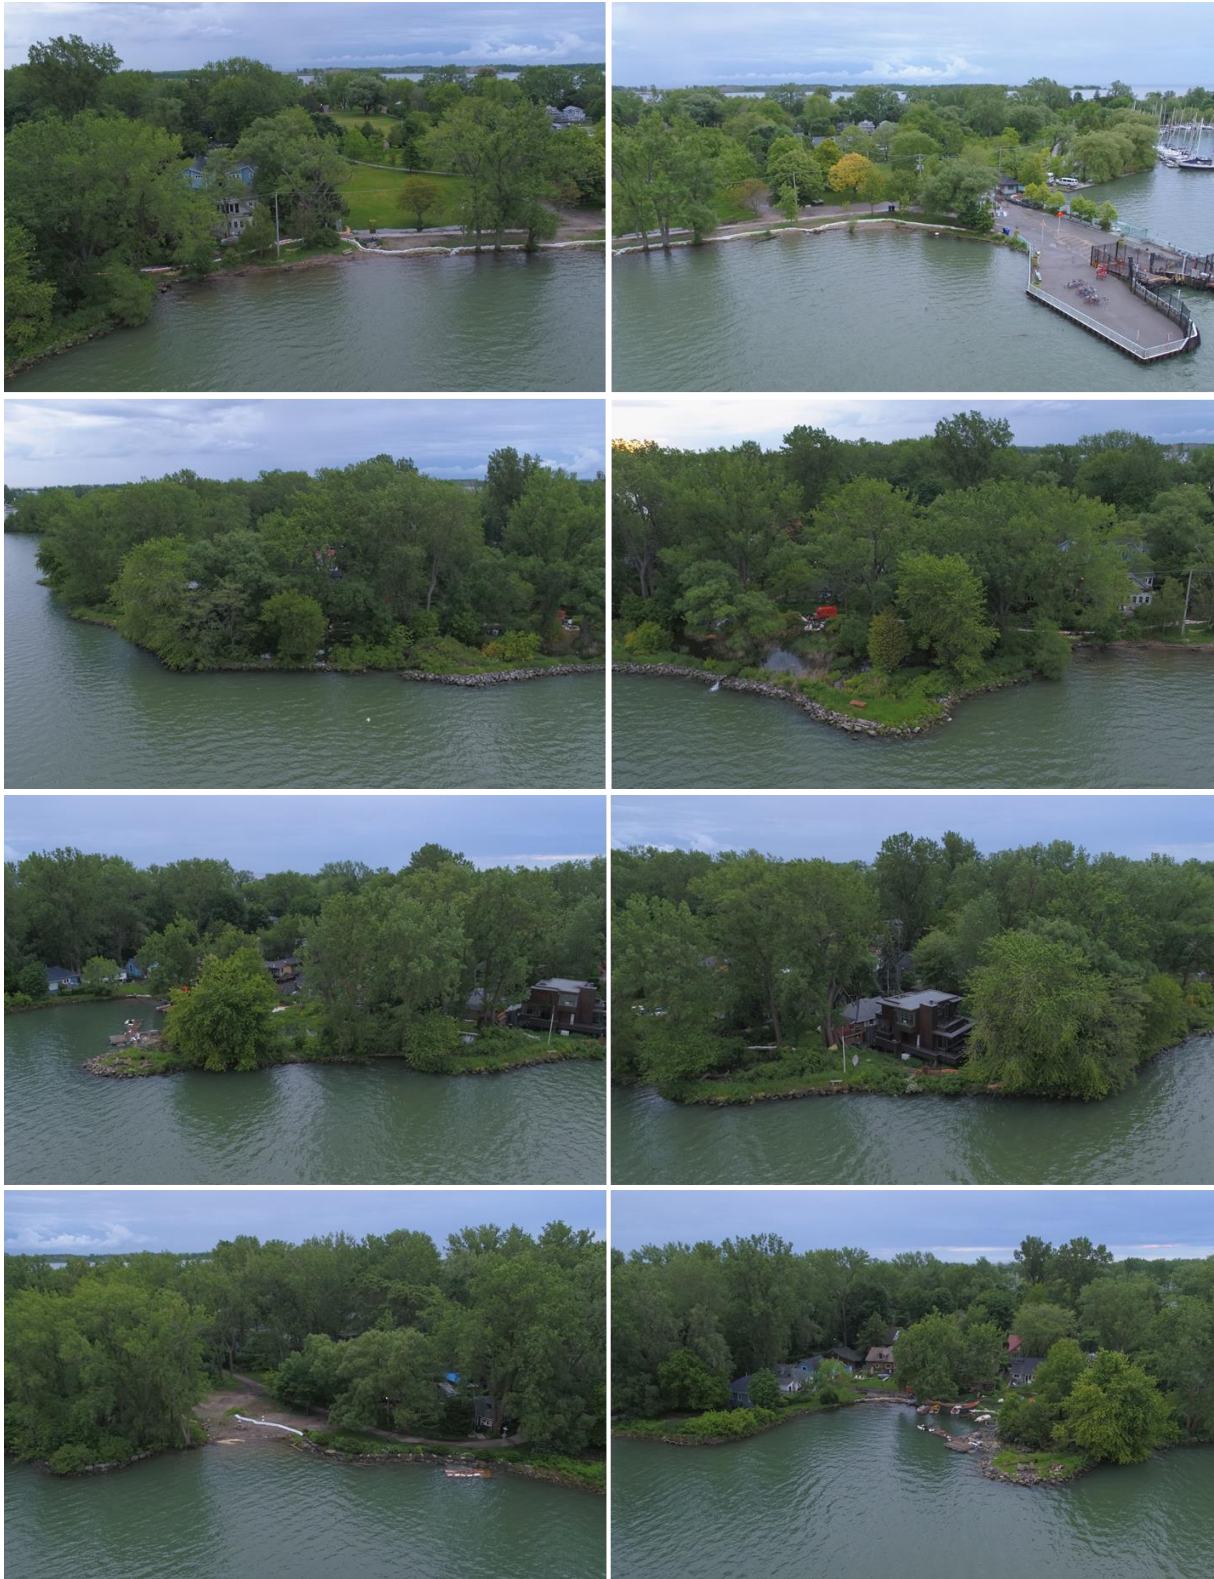
**Figure 5.1: Photographs of the Ward's Island Shoreline from the Ferry Dock to the Cove**

Unmanned Aerial Vehicle photographs of the Ward's Island shoreline from the ferry dock to the cove are shown in Figure 5.1 (photographs provided by TRCA).

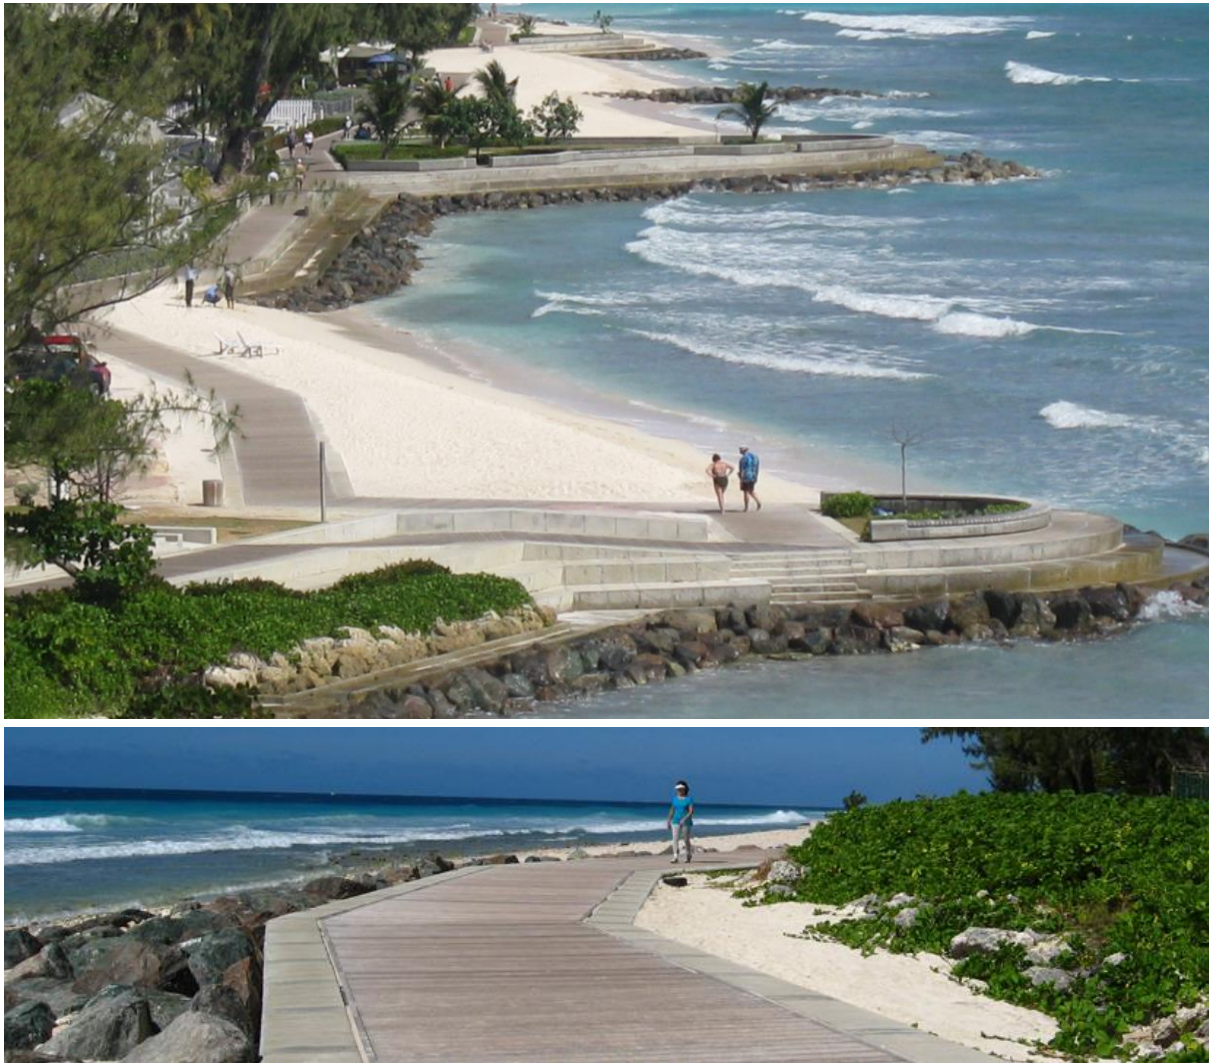
**Figure 5.2: Example Similar to the Ward's Island Promenade Concept**

The promenade concept for Ward's Island is similar to a design Baird has used on other projects, including the Rockley Boardwalk in Barbados (see Figure 5.2). A similar design implemented at Ward's Island would offer benefits to residents and visitors including flood protection and recreation. Options 1, 2, and 3 include armourstone groynes and sand or gravel pocket beaches. If desired, the size of the groynes could be increased, making the features into artificial headlands like those along the Rockley Boardwalk. The promenade is intended to draw in visitors disembarking from the ferry and direct them along the shoreline rather than down residential streets. The pathway will run along the back of the beaches and connect with the existing pathway/street network. A seat wall running along the pathway would provide opportunities for residents and visitors to stop to view the City and use the beaches. A berm will be installed on the landward side of the pathway for flood protection. A Geosynthetic Clay Liner, consisting of two geotextile outer layers and a bentonite clay core, would be installed in the berm to reduce seepage through the berm during high lake levels.

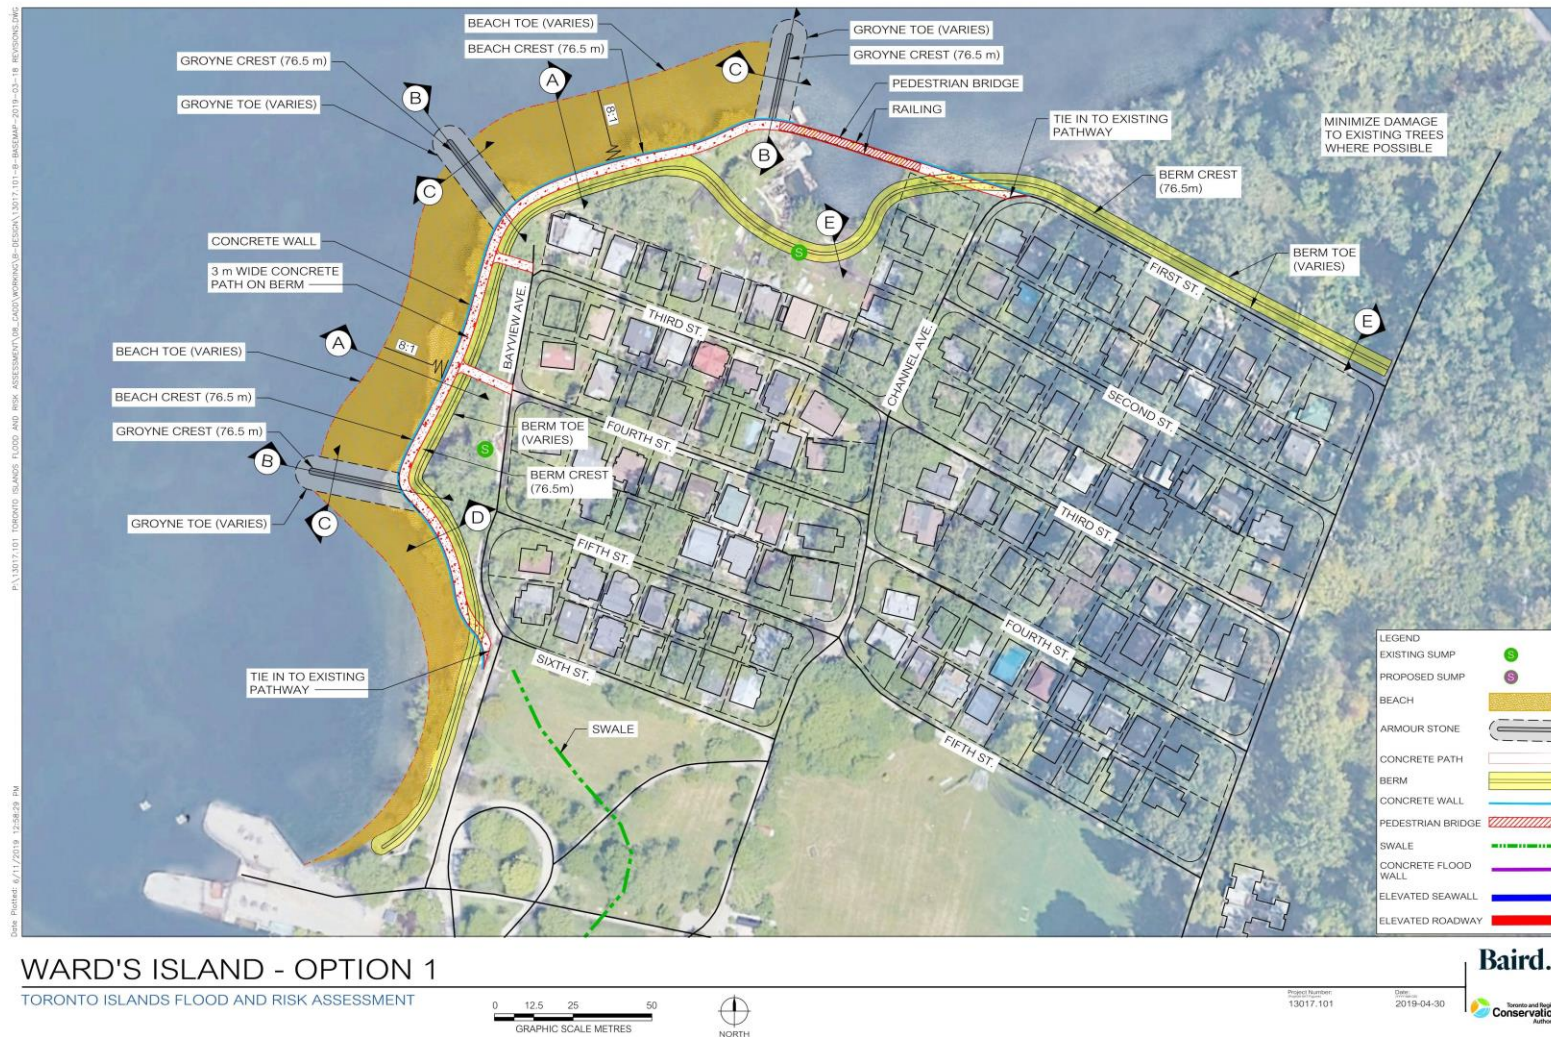
Figure 5.3: Plan View of Ward's Island Promenade Option 1

- **Option 1:** Promenade extending from the Ward's Island ferry dock to the intersection of First Ave. and Lakeshore Ave. Includes three groynes, three beaches, and a pedestrian bridge over the Ward's Island cove.
- **Option 2:** Shorter promenade extending from the Ward's Island ferry dock to the intersection of Bayview Ave. and Third Ave. Includes two groynes and two beaches.
- **Option 3:** Shorter promenade than Option 2 extending from the Ward's Island ferry dock to the first groyne. Includes one groyne and one beach.
- **Option 4:** Berm only option. Berm follows the shoreline from the Ward's Island ferry dock to the intersection of First Ave. and Lakeshore Ave.

The four options for the Ward's Island Promenade are shown on the following pages in plan view (Figure 5.3 to Figure 5.6). Profiles and cross-sections of the promenade, groynes, and berm are provided in Figure 5.7 to Figure 5.11. Larger drawings are provided in Appendix B.

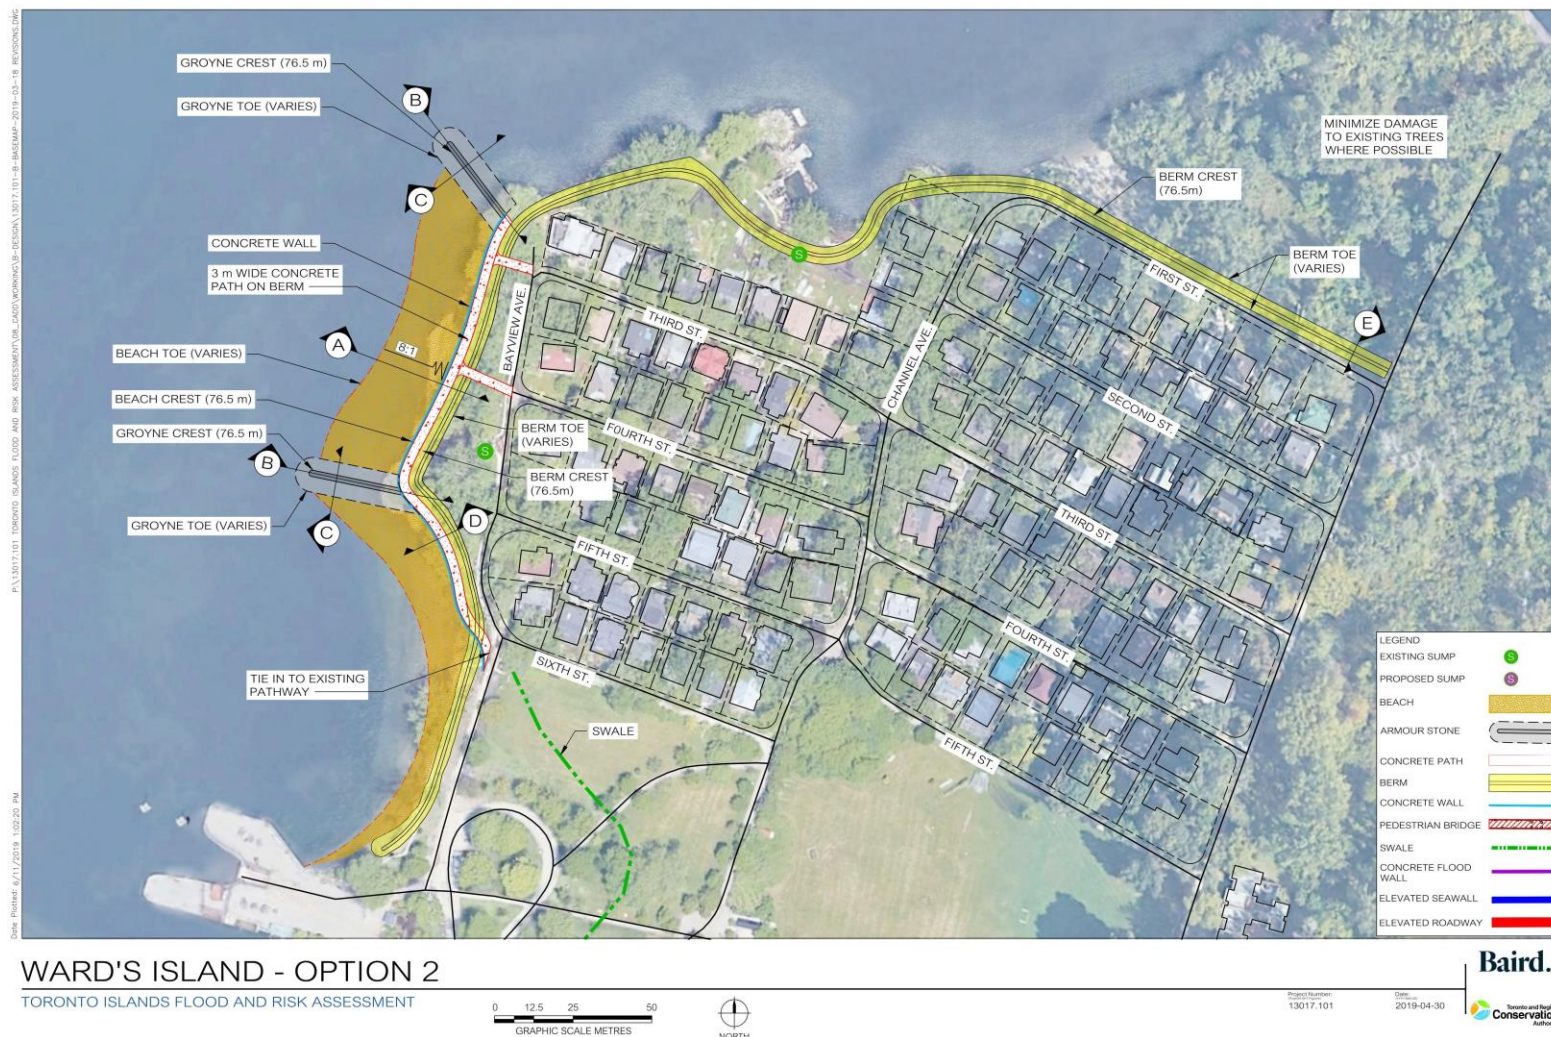
Figure 5.4: Plan View of Ward's Island Promenade Option 2

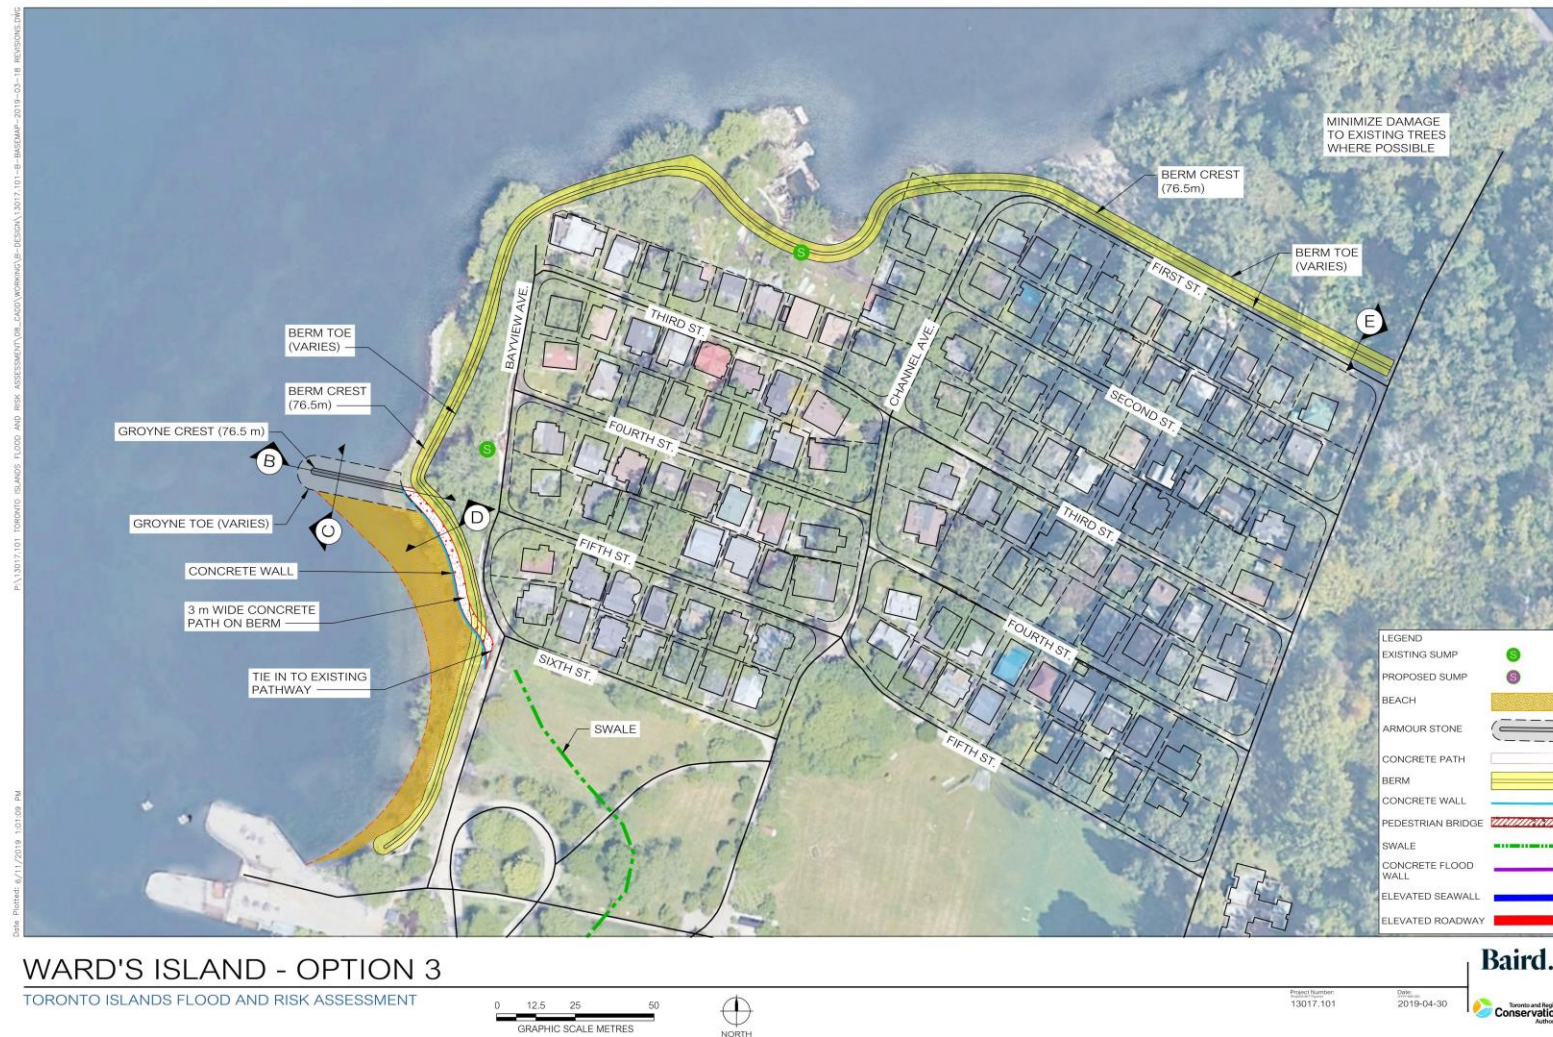
Figure 5.5: Plan View of Ward's Island Promenade Option 3

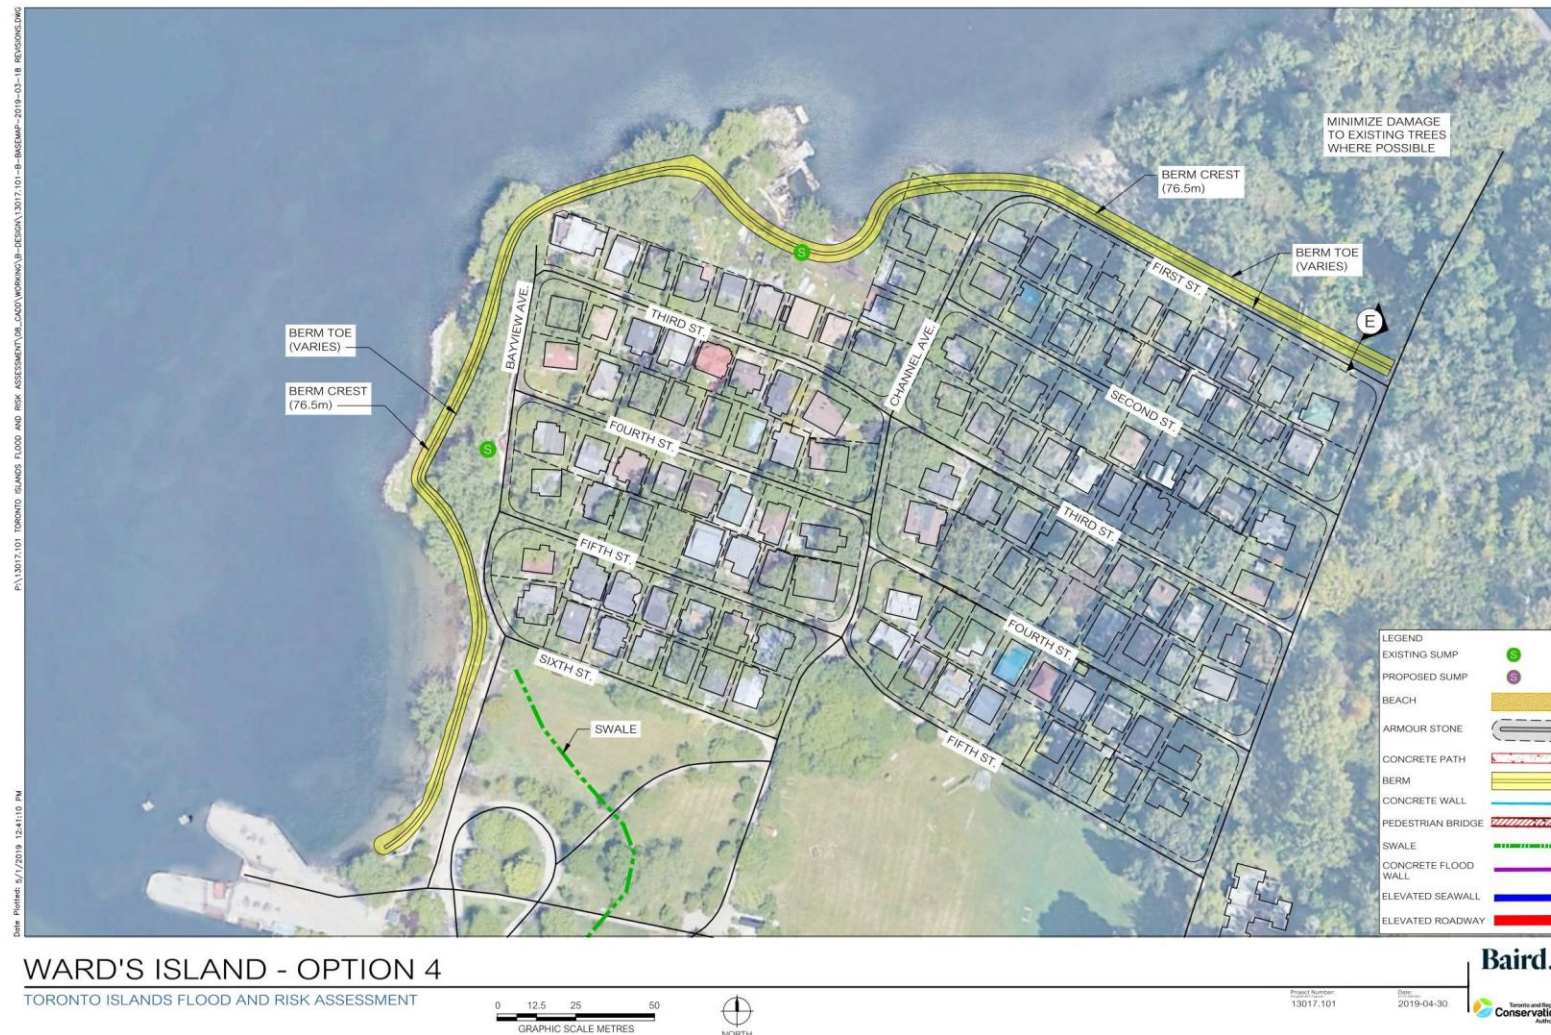
Figure 5.6: Plan View of Ward's Island Promenade Option 4

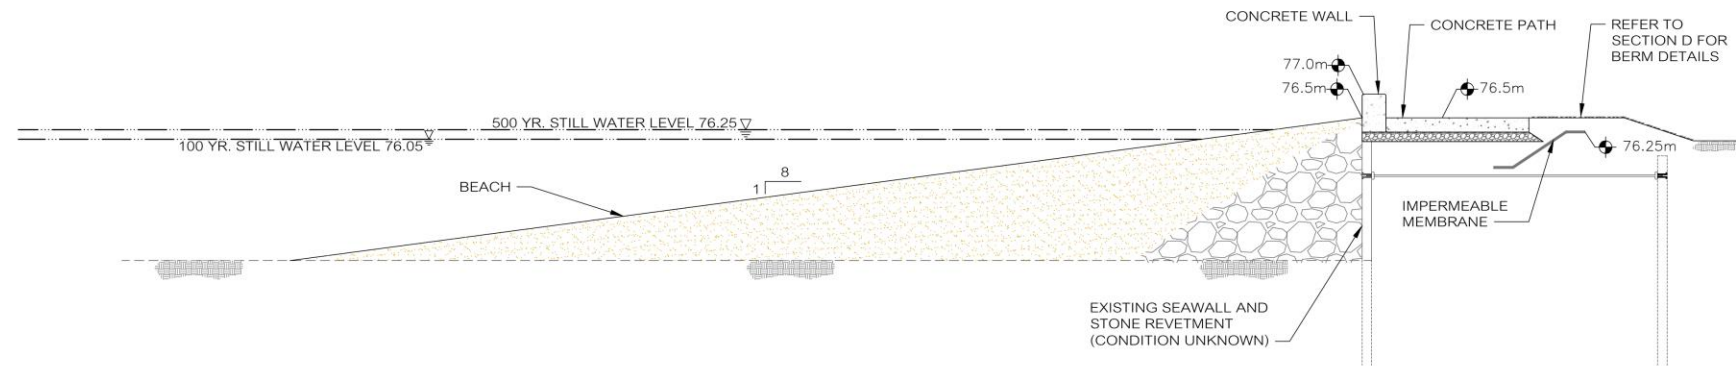
A SECTION - BEACH

Figure 5.7: Profile of Ward's Island Promenade and Beach

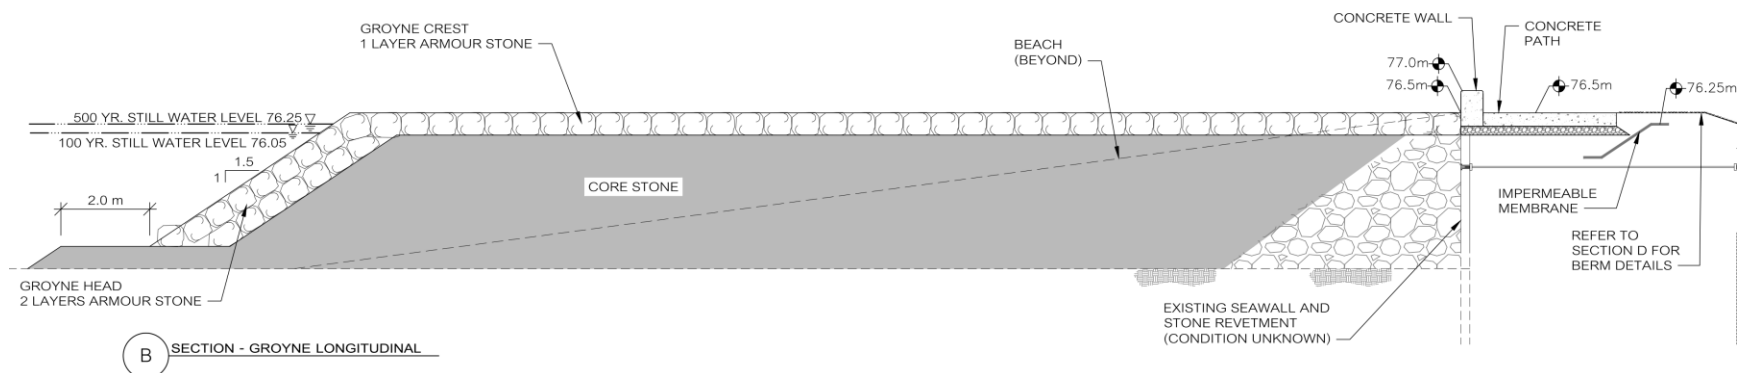
B SECTION - GROUYNE LONGITUDINAL

Figure 5.8: Profile of Ward's Island Promenade and Groyne

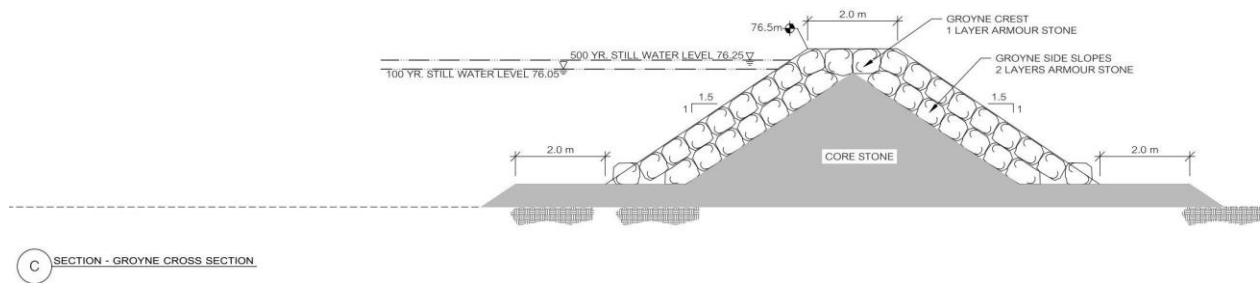
Figure 5.9: Cross-section of Ward's Island Groyne

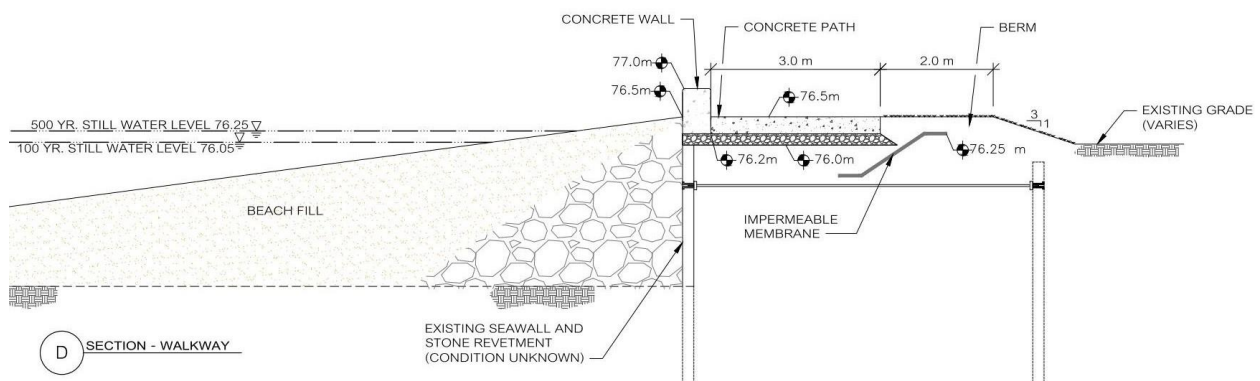
Figure 5.10: Profile of Ward's Island Promenade

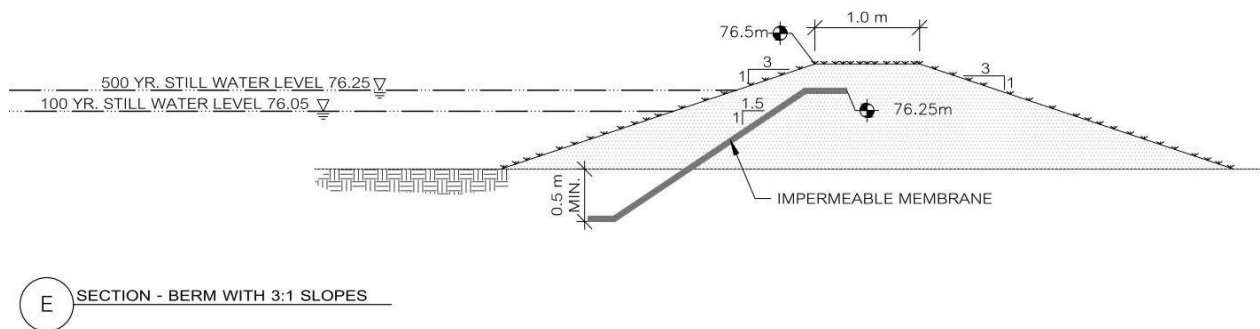
Figure 5.11: Cross-section of Berm

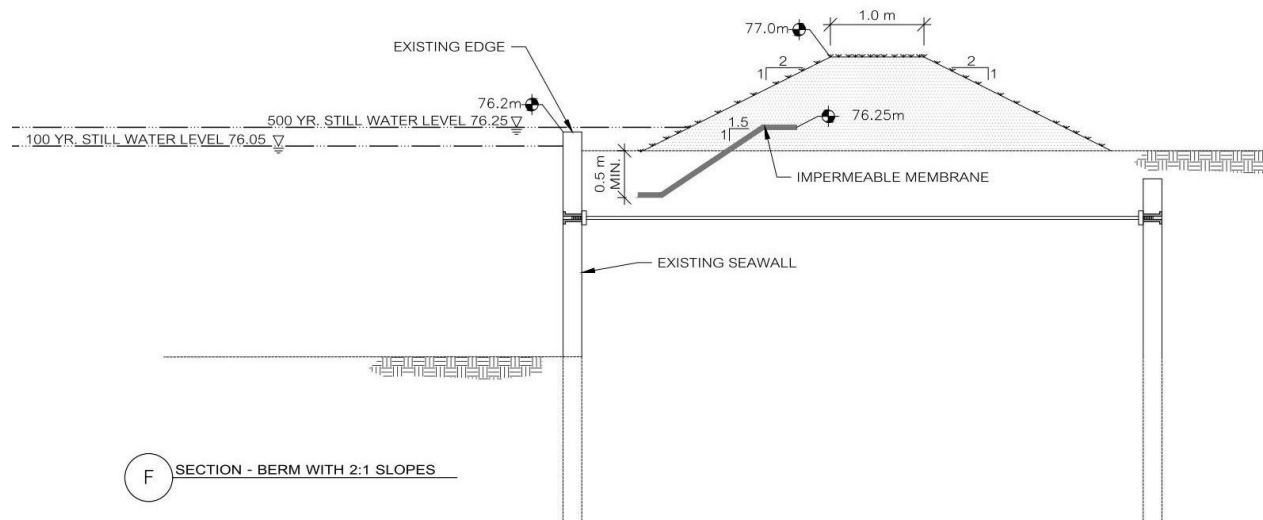
**Figure 5.12: Cross-section of Algonquin Island Berm Along Seawall**

An approximately 1 m high berm is proposed along the Algonquin Island seawall to reduce the volume of wave overtopping (see Figure 5.12). The crest of the berm along the seawall is 0.5 m higher than the standard berm elevation due to the greater wave exposure at the seawall (compared to areas further inland). The berm would extend from the Queen City Yacht Club to the Algonquin Island Association clubhouse before transitioning to the standard berm cross-section (76.5 m crest elevation). The berm continues from the clubhouse to the intersection of Wyandot Ave. and Omaha Ave. (see Figure 5.14). The berm will occupy nearly the entire grassy strip between the seawall and Seneca Ave. A walking trail is not proposed on the berm crest due to space limitations. Other configurations, such as a retaining wall or steps on the backslope could be considered in the next phase of the study if a wider crest (and possibly a walking trail) is desired.

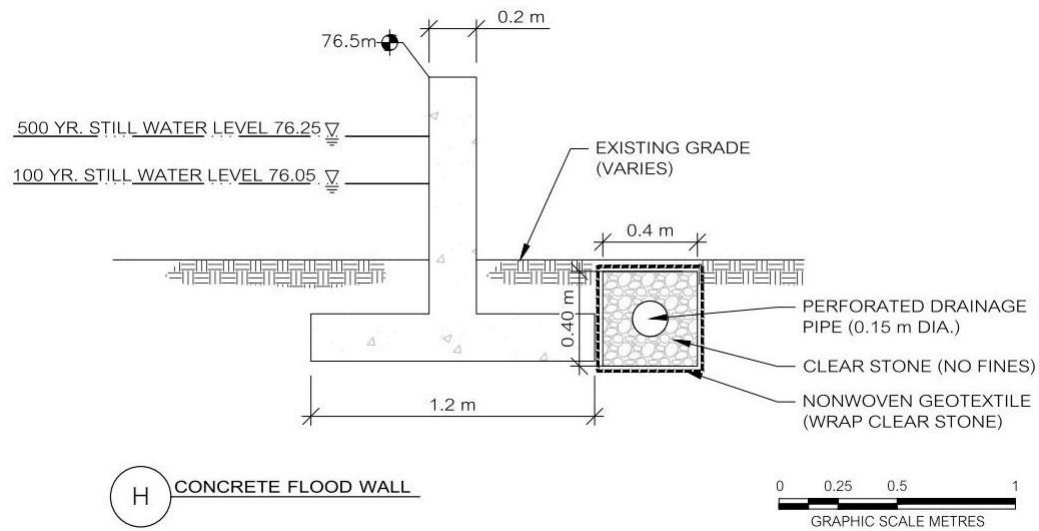
**Figure 5.13: Cross-section of Algonquin Island Flood Wall**

A concrete flood wall is proposed behind the homes on Nottawa Ave. that back onto the Queen City Yacht Club as there isn't sufficient space for a berm. However, the possibility of using a berm at this location should be discussed with home owners and the yacht club. A conceptual drawing of the flood wall is shown in Figure 5.13. A perforated drain along the interior of the wall is proposed to direct water towards the existing sump on Seneca Ave.

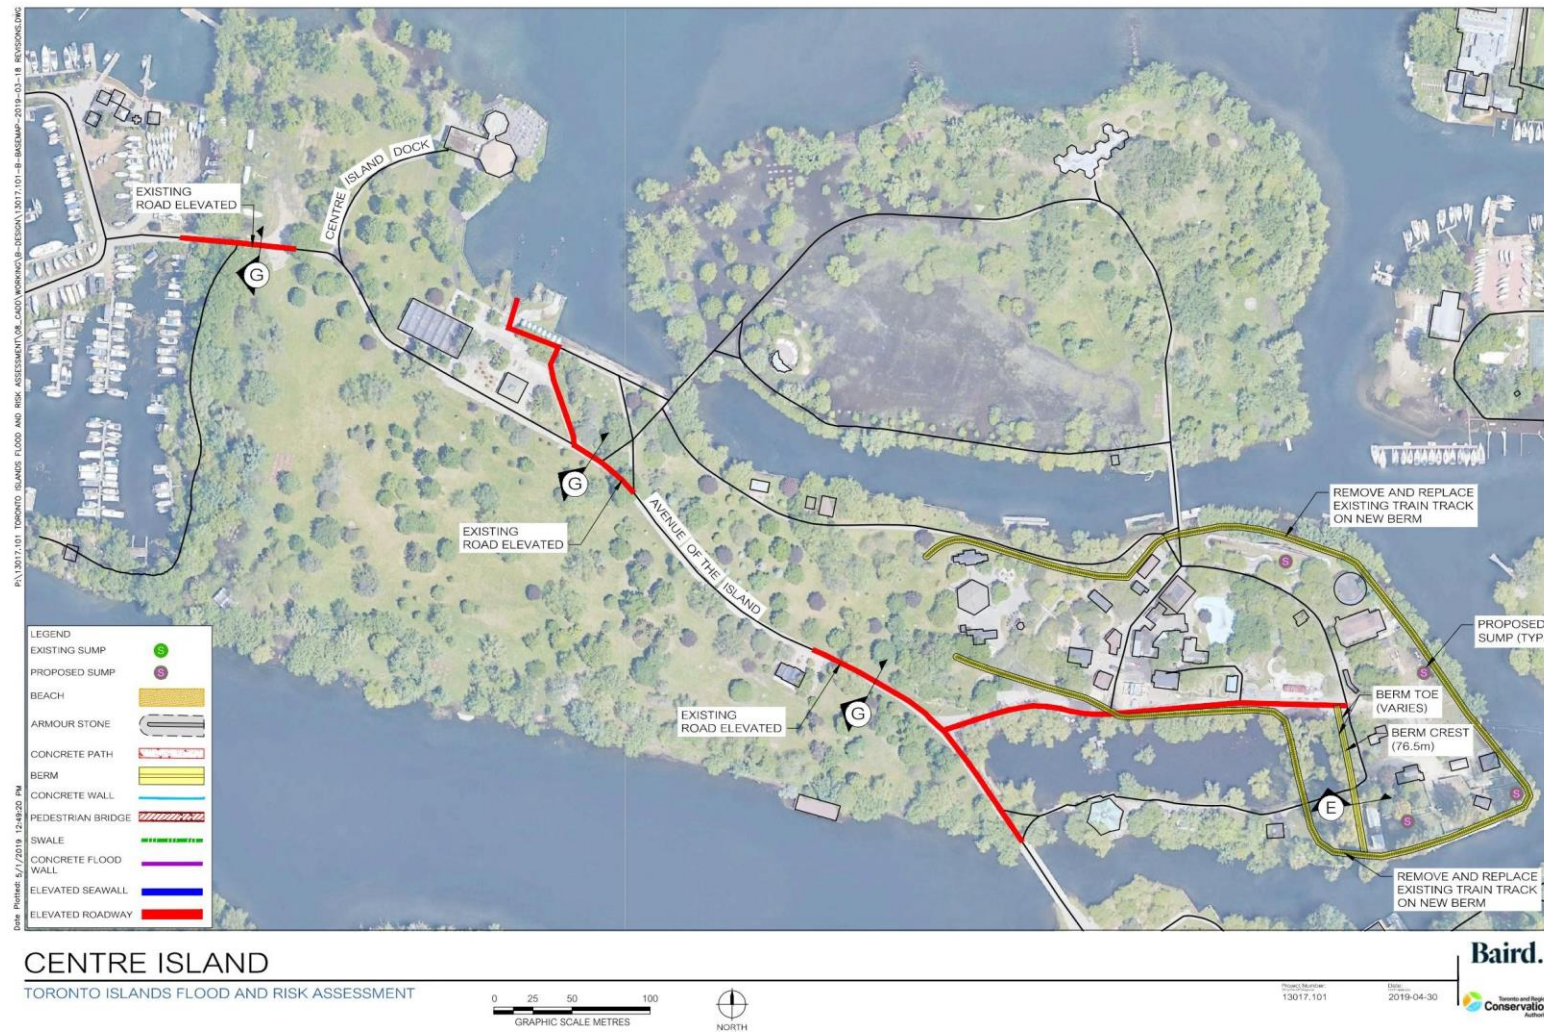
Figure 5.15: Plan View of Centreville Flood Protection

The Centreville Amusement Park was highly impacted by the 2017 flooding. Considering that the Centreville train encircles nearly all of the Centreville buildings, an idea was put forth in the meetings to rebuild the trackbed to also function as a flood protection berm. The berm could be built parallel to the trackbed or the trackbed could be raised and reconstructed with an impermeable liner. Similar to the other berm locations, 1 or 2 m wide gaps in the berm or culverts with one-way valves would be required to allow rainwater to drain towards the lake. These gaps would be closed with sandbags, stoplogs, gates, or other deployable barriers during high lake levels. Sumps are also proposed at four low spots within the Centreville property. The location of the berm and sumps are shown in Figure 5.15.

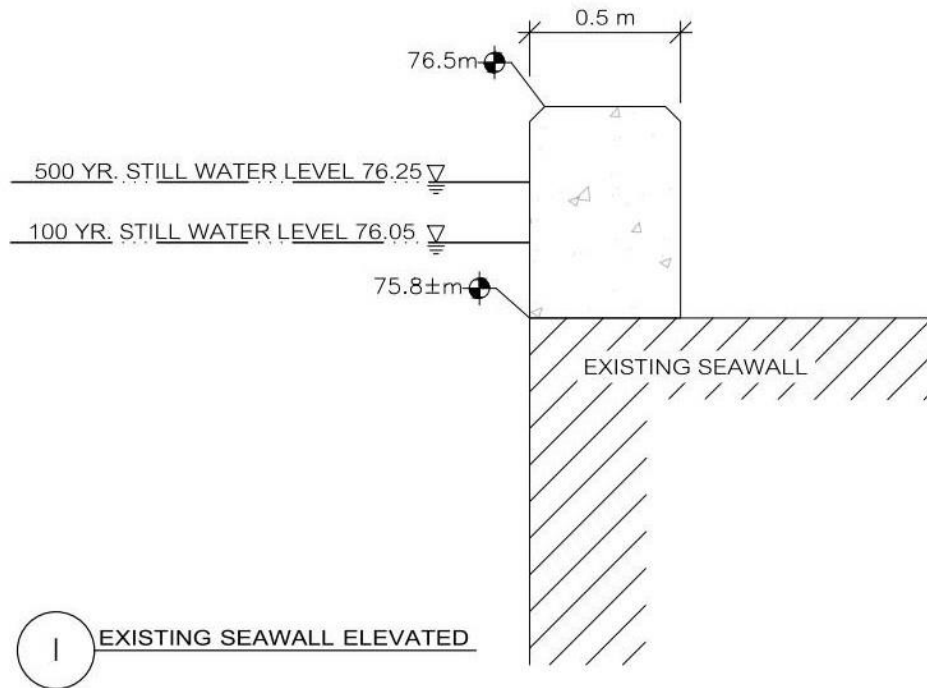
**Figure 5.16: Cross-section of Island Water Treatment Plant Concrete Wall on Existing Seawall**

The seawall at the Island Water Treatment Plant was partially inundated in 2017. The proposed concept for the seawall is to replace the temporary jersey barriers with a 0.7 m high by 0.5 m wide concrete wall (see Figure 5.16). The wall could be joined/sealed to the existing seawall deck using a rubber or neoprene membrane and dowels. A small berm around the parking area and elevating most of Service Rd. is also recommended (see Figure 5.17).
