# Toronto Islands Flood Characterization and Risk Assessment Project

## Flood Mitigation Alternatives Report

4 June 2019 | 13017.101.R3.Rev1\_FloodMitigation

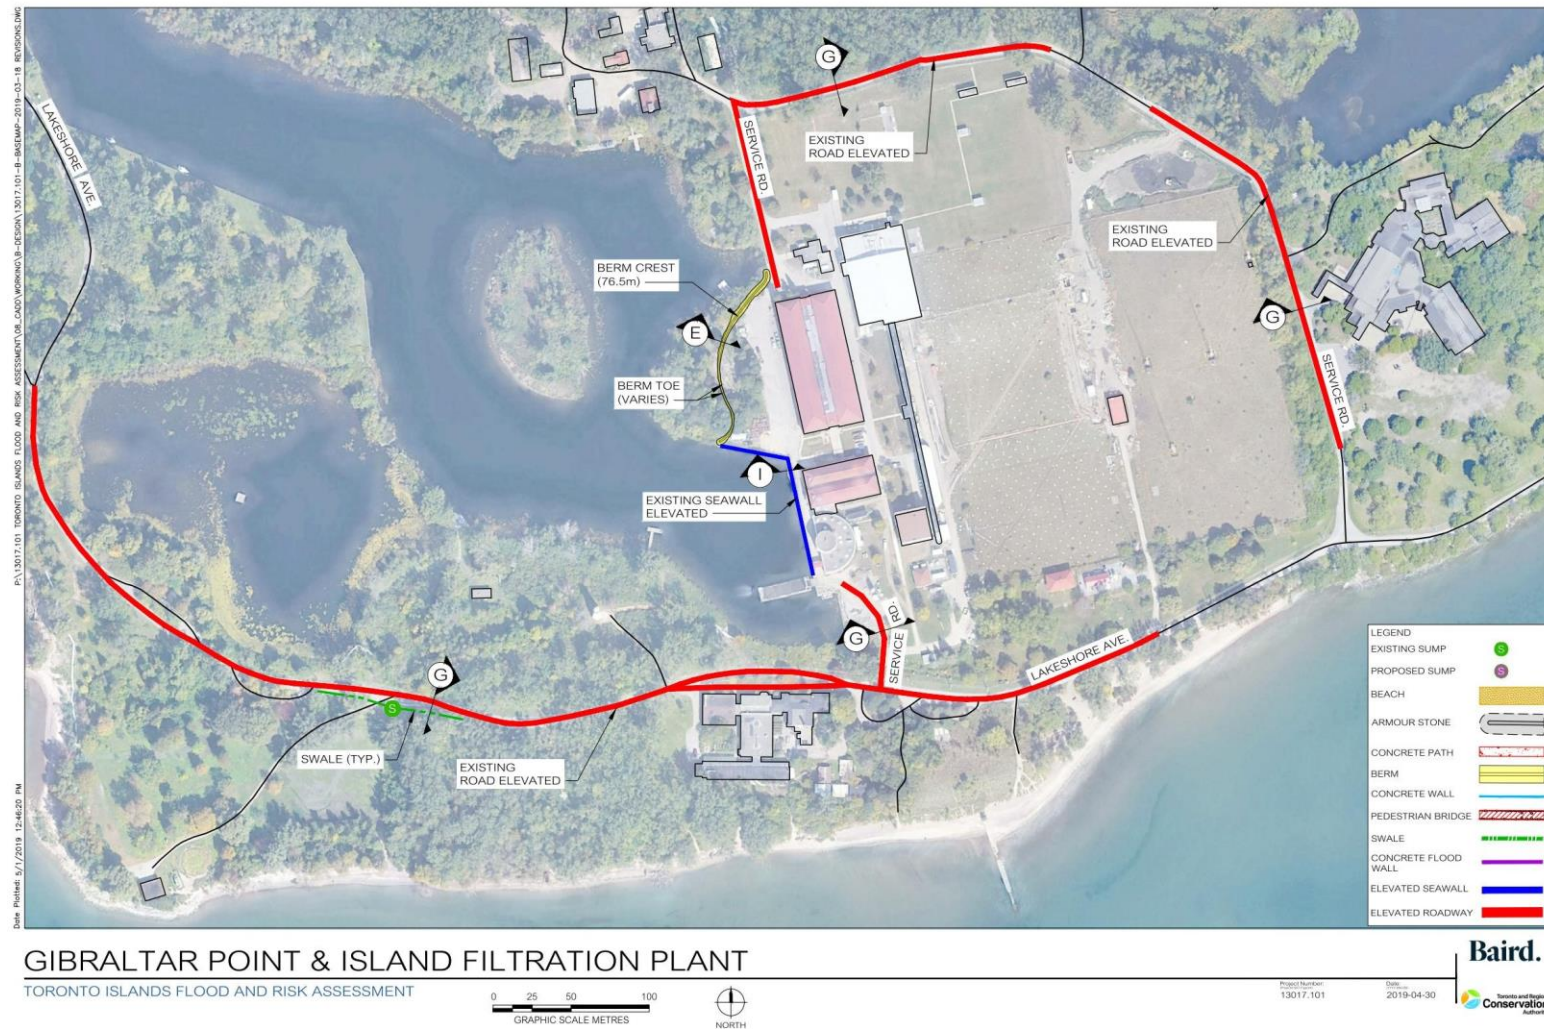
Figure 5.17: Plan View of Island Water Treatment Plant Flood Protection

The seawall at the Island Water Treatment Plant was partially inundated in 2017. The proposed concept for the seawall is to replace the temporary jersey barriers with a 0.7 m high by 0.5 m wide concrete wall (see Figure 5.16). The wall could be joined/sealed to the existing seawall deck using a rubber or neoprene membrane and dowels. A small berm around the parking area and elevating most of Service Rd. is also recommended (see Figure 5.17).

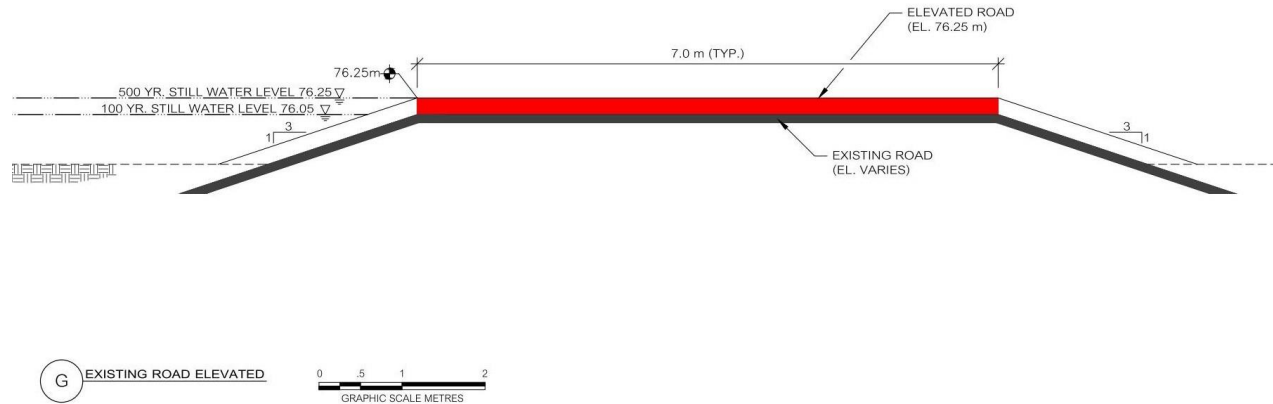
**Figure 5.18: Cross-section of Road Improvements**

Portions of the arterial roads are flooded at moderate flood levels. Low spots should be elevated to 76.25 m to provide safe ingress/egress (see Figure 5.18). The proposed locations of the road improvements are shown in the previous plan view figures and Figure 5.19. The most critical areas are Cibola Ave. south of the Fire Station and Lakeshore Ave. at Gibraltar Point.

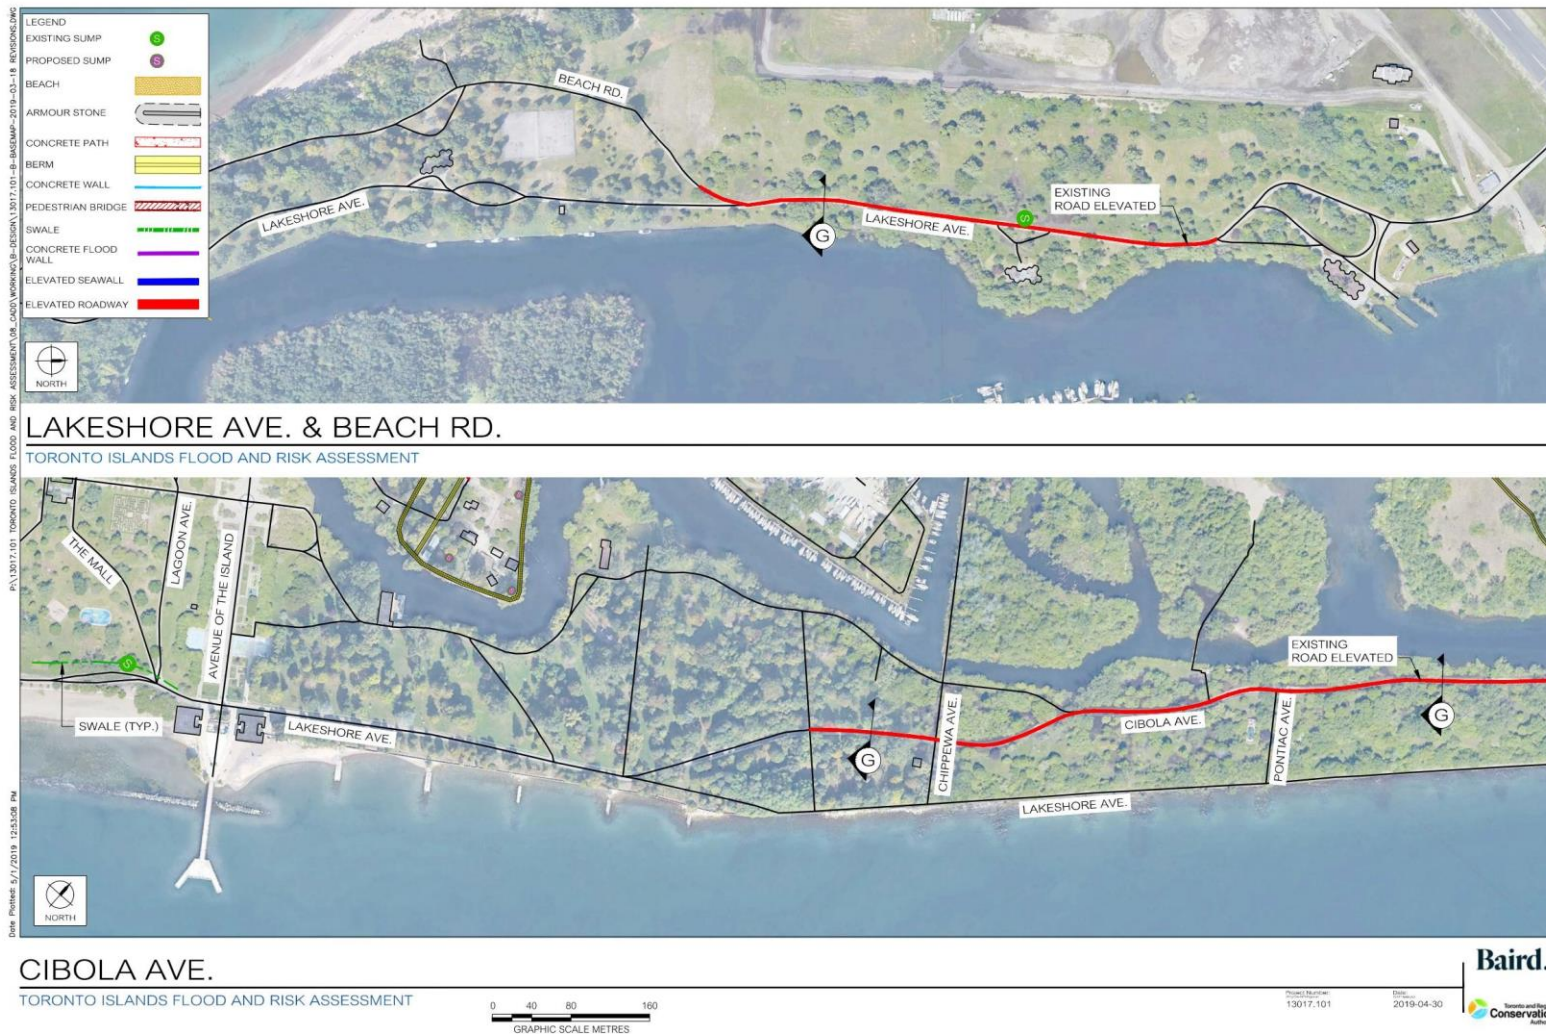
Figure 5.19: Plan View of Cibola Ave. and Lakeshore Ave. Road Improvements

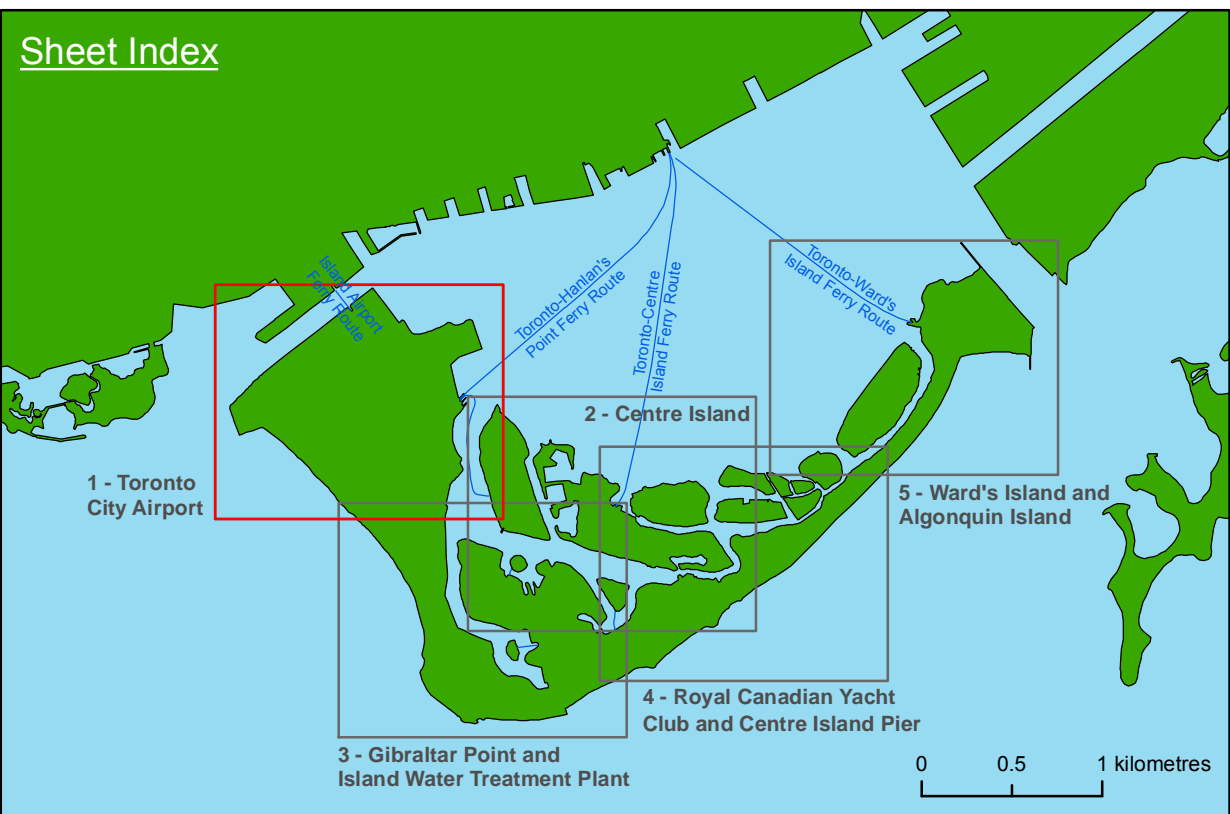
# Toronto Islands Flood Depth Map

Water Level = 76.2 m IGLD85

The flood depth maps produced for a lake level of 76.2 m (approximately the 500-year flood event) are included in Appendix A to provide context for the flood mitigation alternatives presented in the report. The maps use one colour scale to show the depth of flooding on land, and another scale to show the depth of flooding on the arterial roads. An example of the flooding that occurred along parts of Cibola Ave. in 2017 is shown in Figure 3.2. The 500-year flood level is approximately 0.3 m higher than the water level in the photograph.

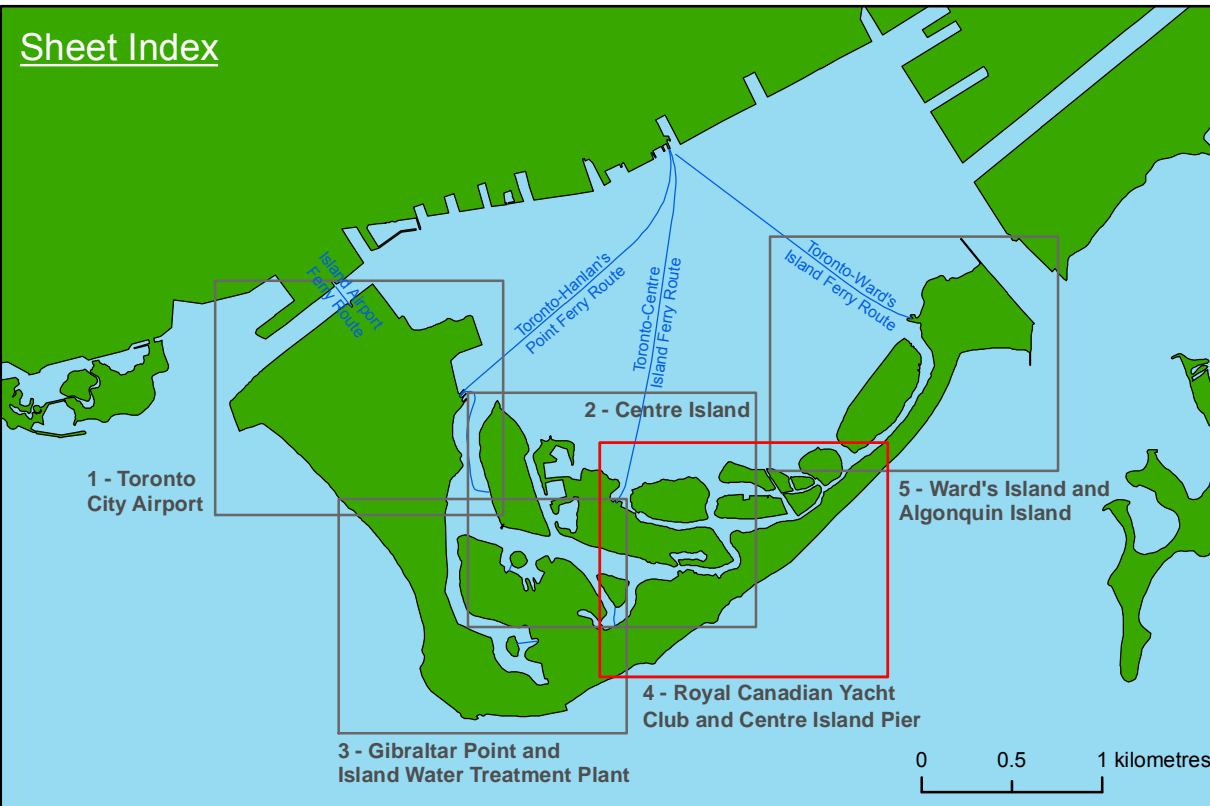
# Toronto Islands Flood Depth Map

Water Level = 76.2 m IGLD85

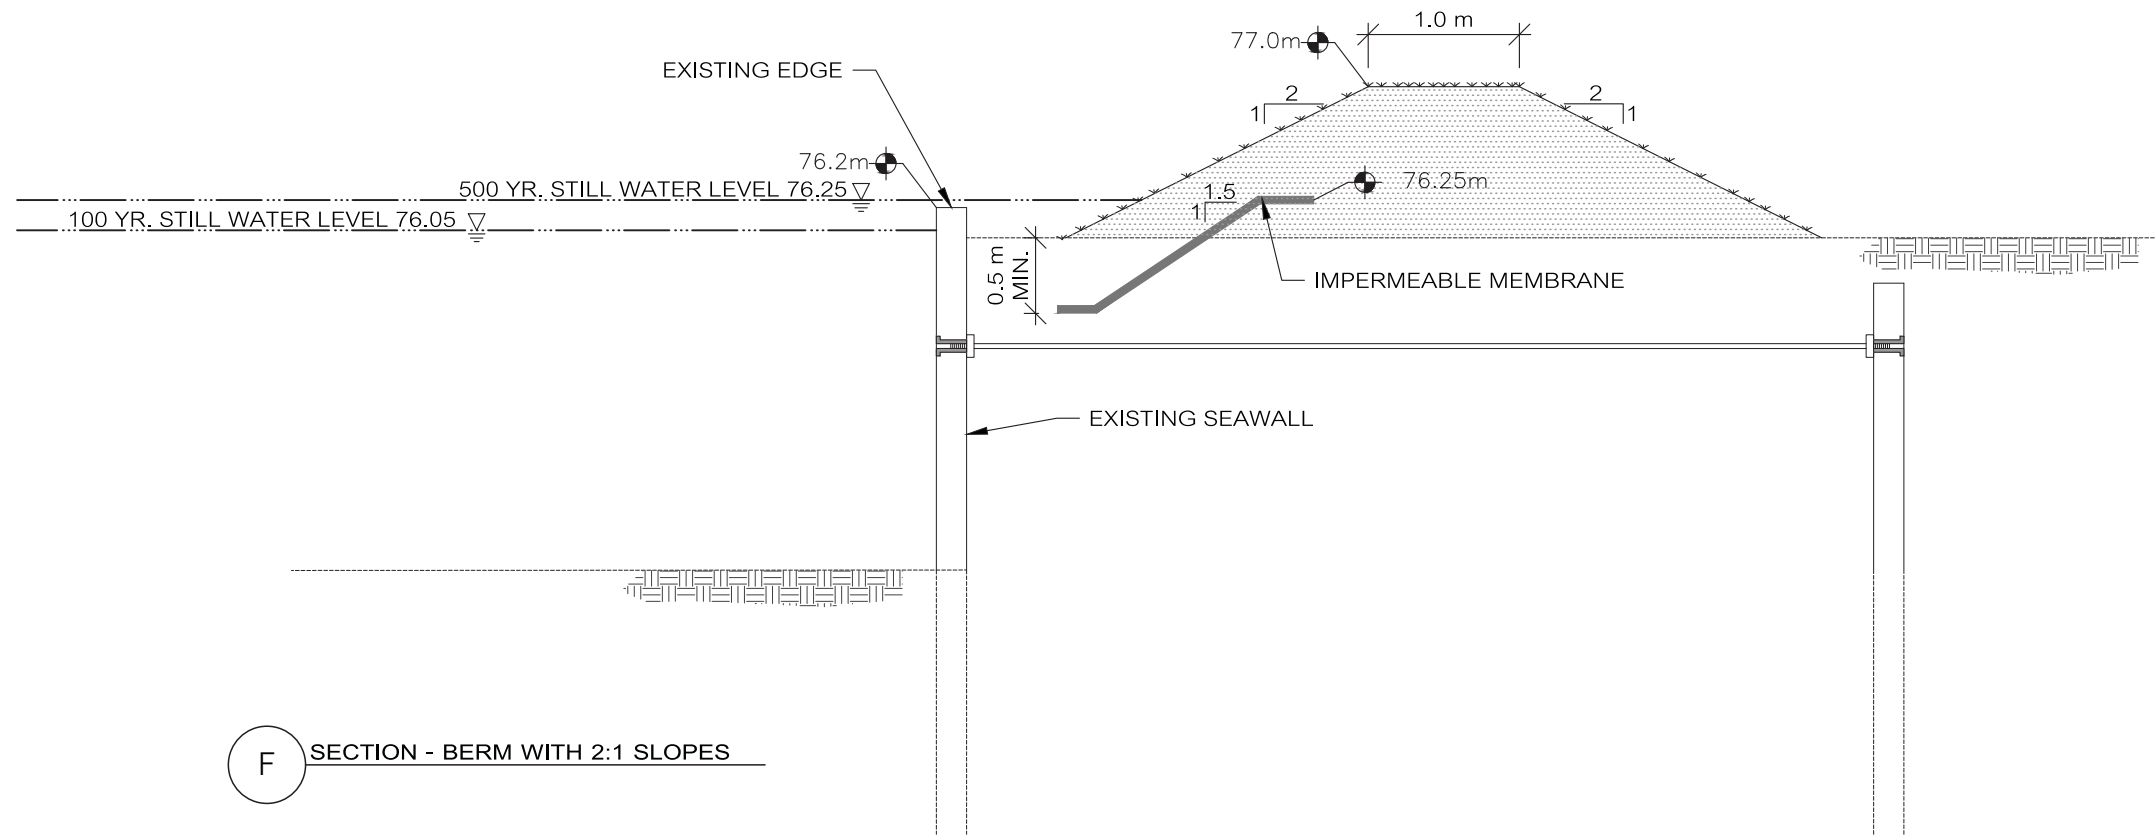
**F** SECTION - BERM WITH 2:1 SLOPES

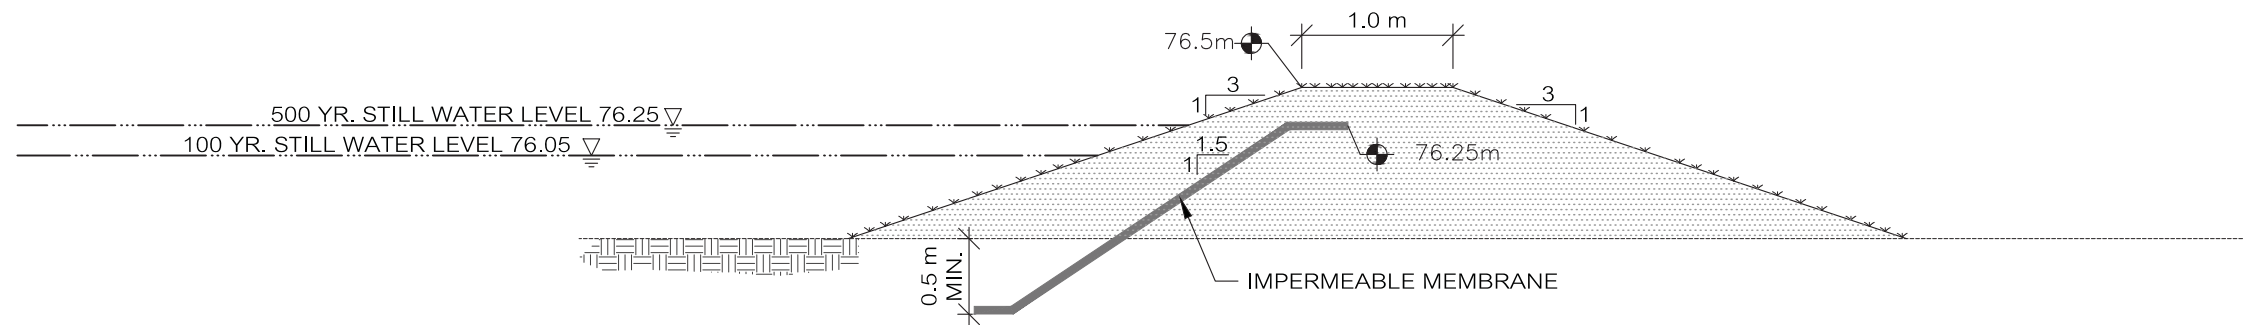
**E** SECTION - BERM WITH 3:1 SLOPES

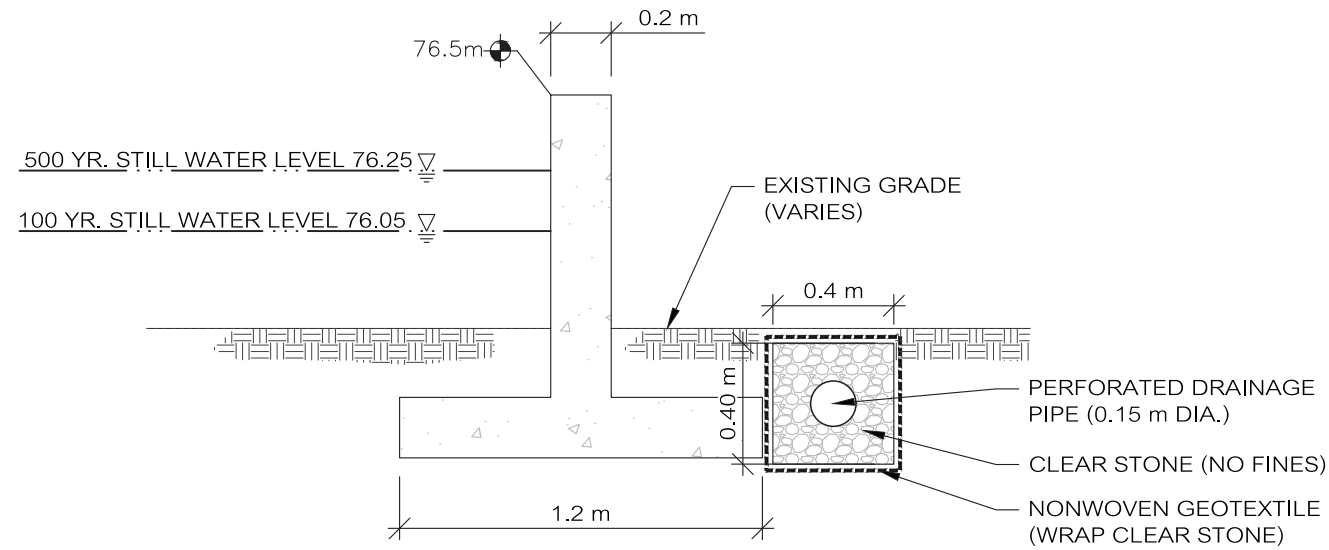
**H** CONCRETE FLOOD WALL

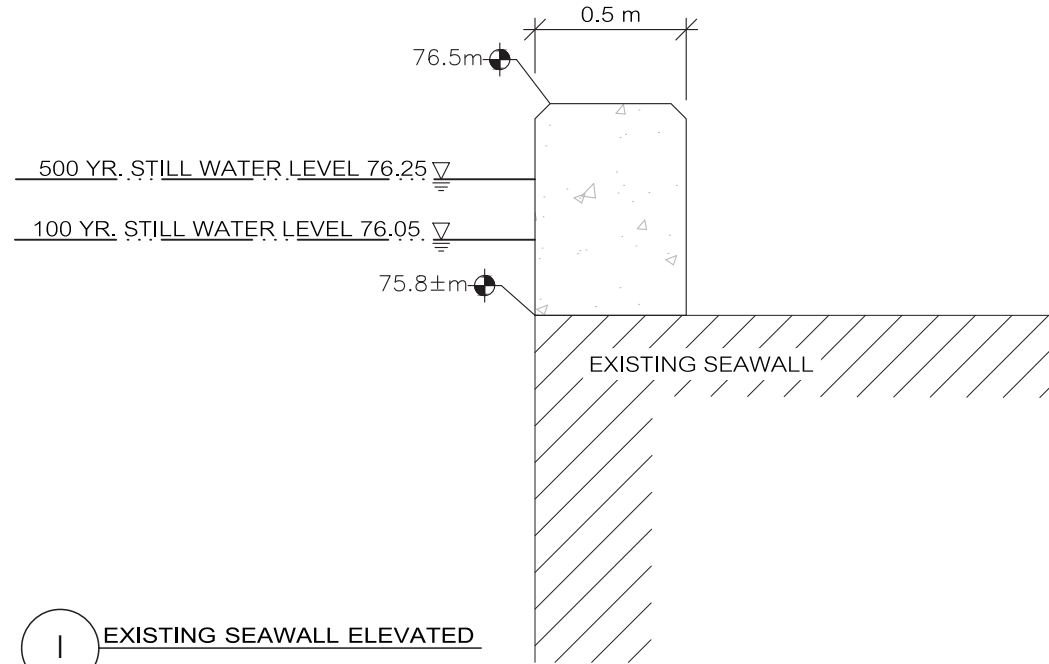
**I** EXISTING SEAWALL ELEVATED

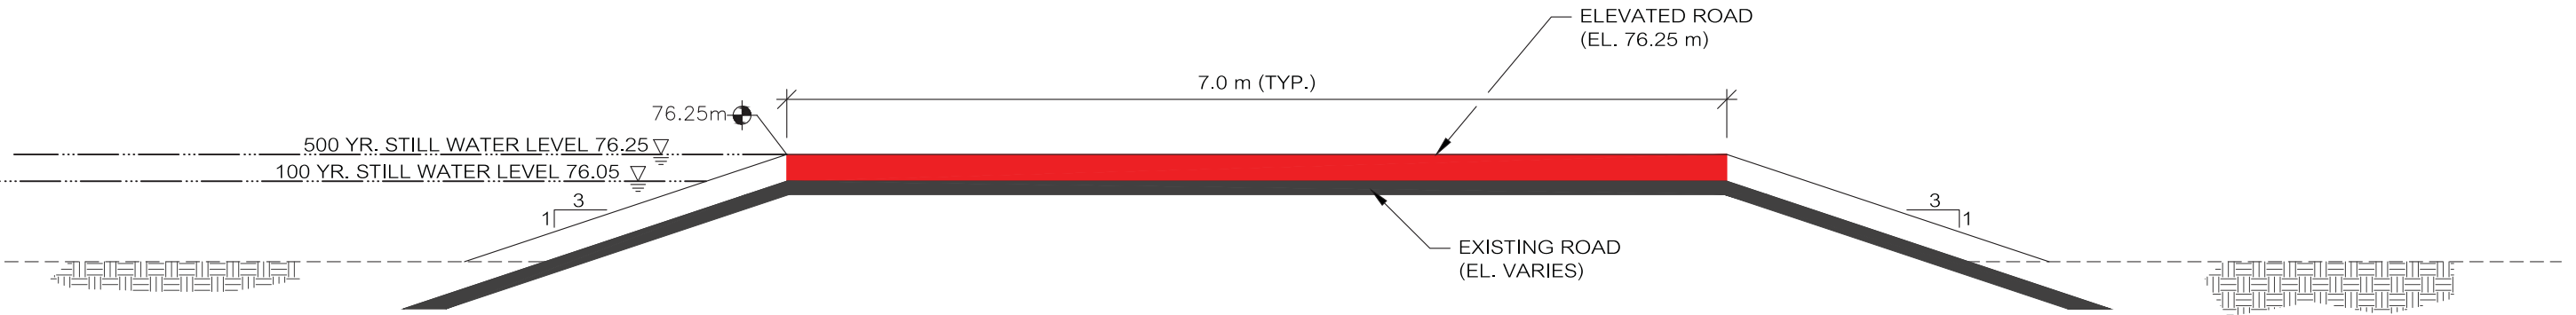
**G** EXISTING ROAD ELEVATED
