German Mills Creek Sanitary Infrastructure Protection Project Site P-057 (YOR-006)

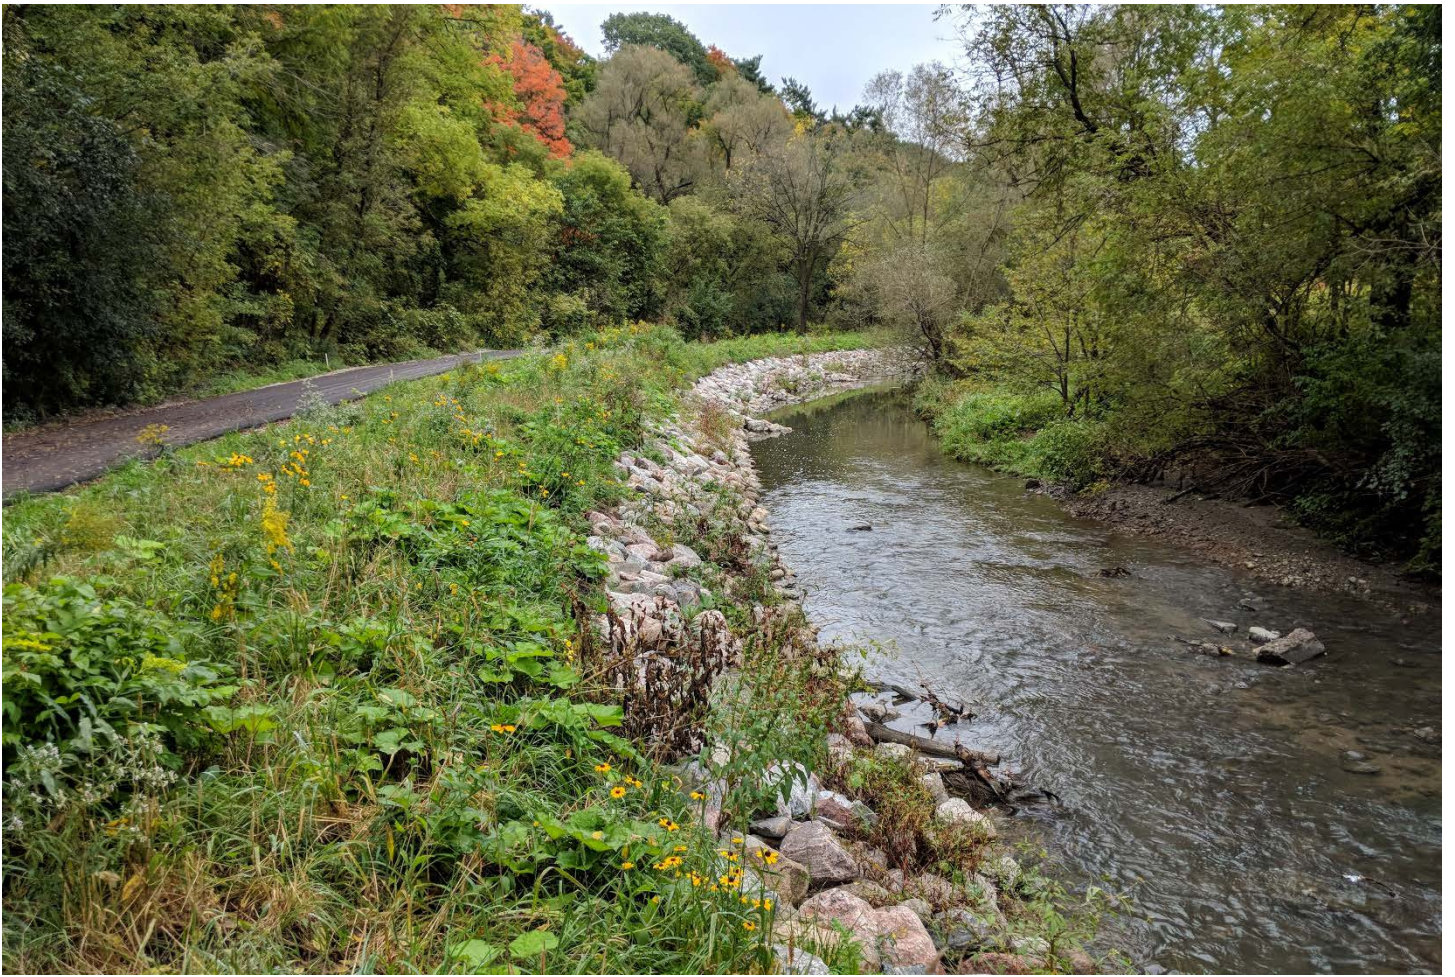
Figure 2. Round stone revetment at Site P-057. *Source: TRCA, 2018.*

Remedial bank stabilization works at Site P-057 (**Figure 1**) included the installation of a 130-metre-long round stone revetment, two woody debris treatments and three rock vanes to provide protection to the channel bank immediately surrounding the adjacent York Region sanitary line and associated maintenance hole (**Figure 2**). These remedial works were completed in spring 2018.
