Patterson Creek near Richvale Community Centre Sanitary Infrastructure Protection Project - Site P-507 (YOR-010)

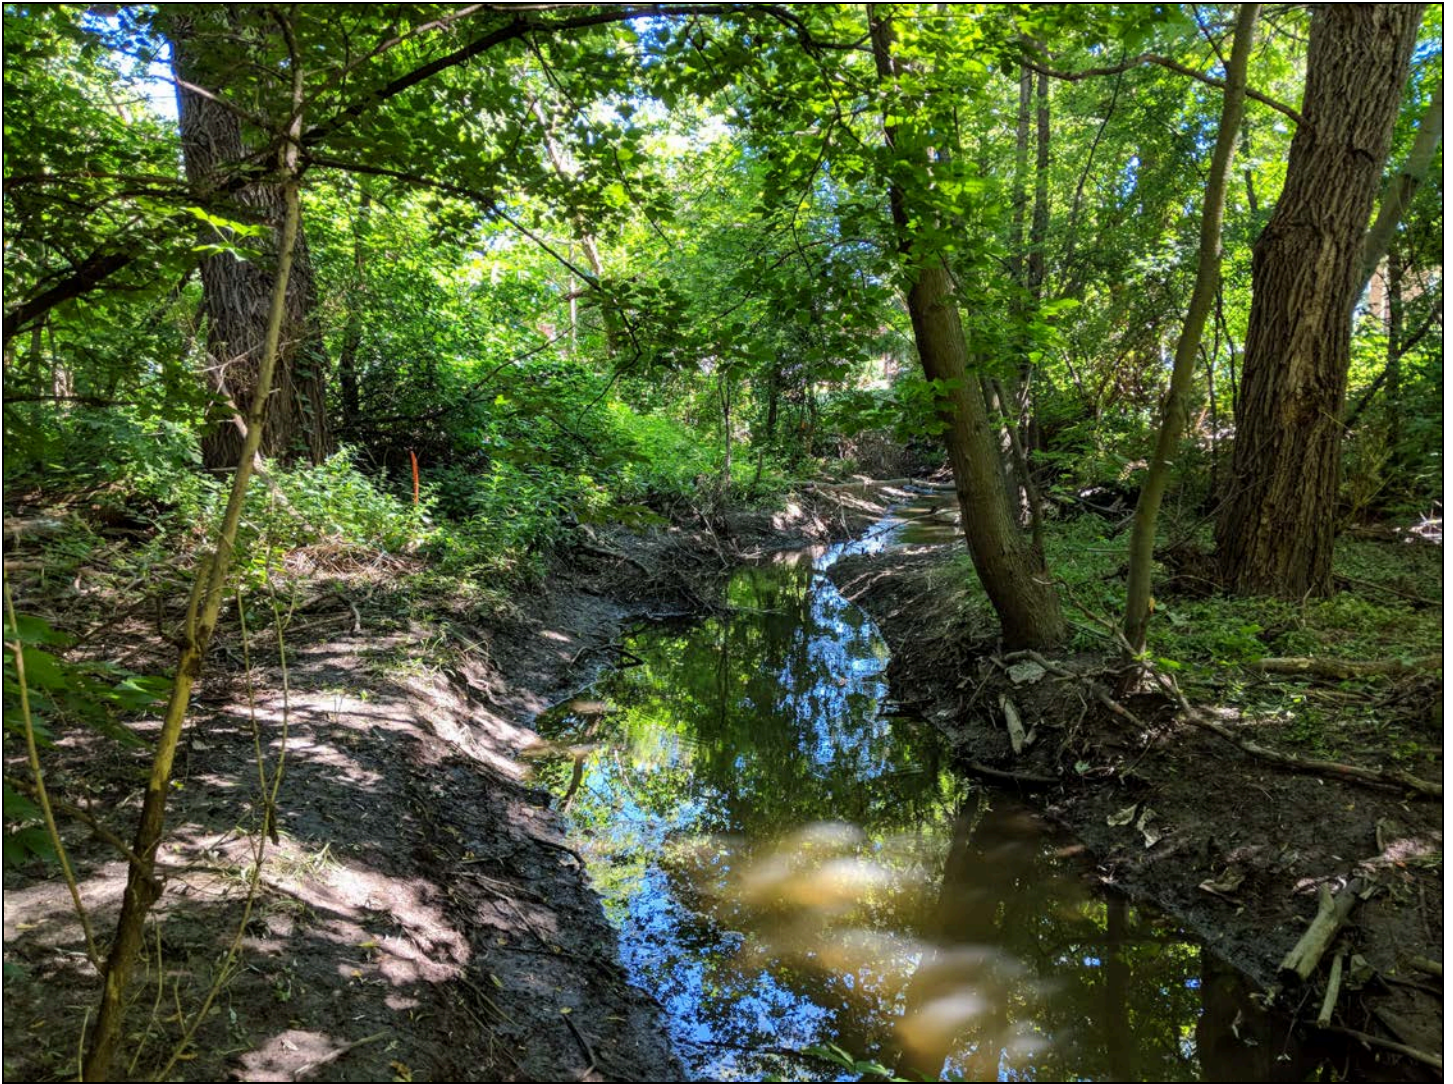
Site P-507 is located along Patterson Creek, southeast of the intersection of May Avenue and Kersey Crescent, within the Town of Richmond Hill (**Figure 1**). TRCA's Infrastructure Hazard Monitoring Program identified erosion in proximity to sanitary trunk sewer infrastructure owned by the Region of York. As such, TRCA commenced a geomorphic assessment in 2017 to further assess risks to infrastructure and property within the study area. The geomorphic assessment categorized erosion as low priority for remediation as of current conditions. TRCA will continue to monitor Site P-507 under the Infrastructure Hazard Monitoring Program to identify any changes within the study area and continue to assess the need for remedial works in the future (**Figure 2**).

Figure 2. Current conditions at Site P-507. *Source: TRCA, 2018.*
